DDAS Accident Report

Report date: 22/01/2004	Accident number: 28
Accident time: 12:30	Accident Date: 03/05/1997
Where it occurred: Songo village, Cahora Bassa, Tete Province	Country: Mozambique
Primary cause: Management/control inadequacy (?)	Secondary cause: Inadequate training (?)
Class: Handling accident	Date of main report: 05/05/1997
ID original source: 0197/IND/NPA field	Name of source: CND/IND/NPA/DG
Organisation: [Name removed]	
Mine/device: AUPS AP frag	Ground condition: not applicable
Date record created: 22/01/2004	Date last modified: 22/01/2004
No of victims: 1	No of documents: 2

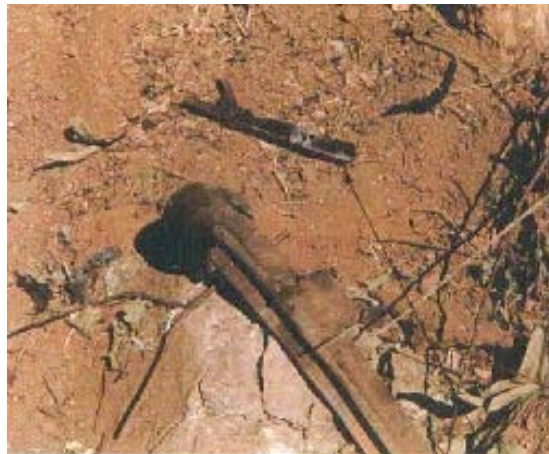
The investigators determined that the victim was squatting over the mine attempting to disarm it with a "Leatherman multi-tool". "The time he worked and that he did not report any difficulties with the fuse suggests no initial problems." When he tried to remove the detonator the mine activated.

The photograph above shows the remains of the victim's Leatherman and the metal stake on which the mine had rested.

AUPS mines with fragmentation jackets were used "in this minefield where the blast mines could not be buried. The mine is mounted on a metal stake and the tripwire attached". This mine was supported on its stake about 30cm above the ground. After the detonation the stake was bent over and could not be removed from the ground.

The investigators recommended that the demining group review its policy of disarming mines in order to bring them in line with International Standards. They also recommended that the demining group "detail the point at which disarming will not continue....detail on who is to make this decision should be included". A further recommendation was for an independent review of the group's "policies, SOPs and disarming procedures" with a view to enhancing safety.

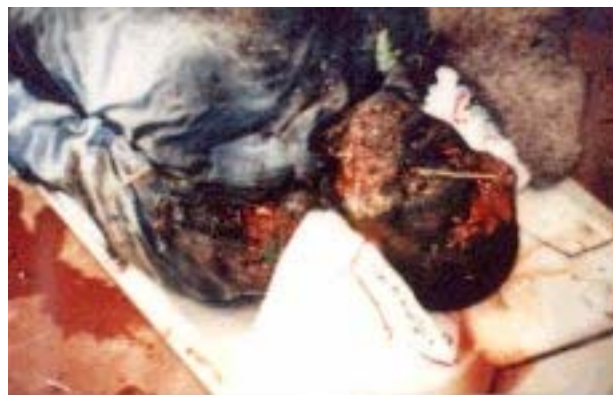
The photograph above shows the injury sustained.

The victim "died immediately of the injuries face destroyed, open head trauma, both hands blown off, open fractures on both legs and right foot blown off".

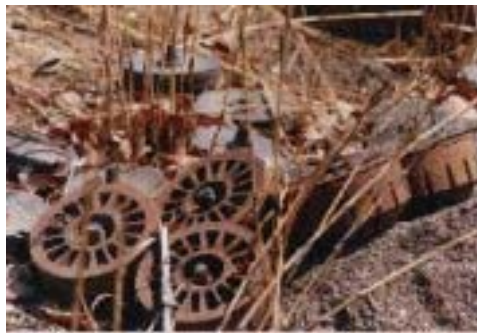
When the researcher visited the site in 1998 many AUPS mines seen on the ground and in piles placed by the local people – who moved them when the presence of the mines inhibited their agricultural activity (shown on the right). The general view at the time was that most of the mines would not operate as designed, and that direct pressure on the rear of the detonator (or stabbing the front) would be required to make one functional.
