# DDAS Accident Report

<b>Report date:</b> 11/03/2004	<b>Accident number:</b> 36
<b>Accident time:</b> 09:25	<b>Accident Date:</b> 04/08/1995
<b>Where it occurred:</b> Sabie, Maputo Province	<b>Country:</b> Mozambique
<b>Primary cause:</b> Field control inadequacy (?)	<b>Secondary cause:</b> Inadequate equipment (?)
<b>Class:</b> Excavation accident	<b>Date of main report:</b> [No date recorded]
<b>ID original source:</b> ADP-5, not dated	<b>Name of source:</b> ADP/CND/IND
<b>Organisation:</b> [Name removed]	
<b>Mine/device:</b> PMN AP blast	<b>Ground condition:</b> sparse trees grass/grazing area
<b>Date record created:</b> 22/01/2004	<b>Date last modified:</b> 22/01/2004
<b>No of victims:</b> 1	<b>No of documents:</b> 2

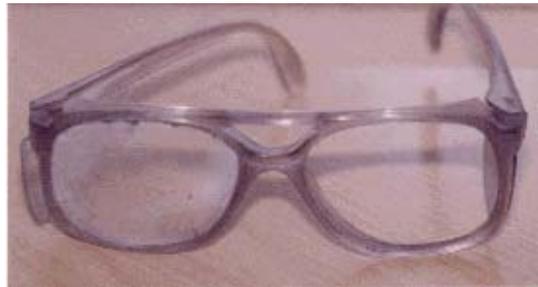
The investigation concluded that the accident was caused by the victim failing to cover all the ground with the detector and by his "vertical digging". The wearing of safety glasses "almost certainly" saved the victim's sight, although the lenses were blown out of the frames and one of the lenses broke. The investigators added "ultimately safety is an individual responsibility".

The victim's safety glasses were photographed by the researcher in 1995.

The investigators saw no need to modify existing techniques. However, where detectors and excavation are used in combination, they recommended that each must be used thoroughly. Further, where detectors could not be used reliably, only excavation should be used so avoiding a lack of alarms being supposed to indicate an absence of mines. Other recommendations included that all deminers be warned about vertical digging and fined if caught, and that the wearing of safety glasses should be enforced (and more durable ones found).
