# DDAS Accident Report

<b>Report date:</b> 19/04/2006	<b>Accident number:</b> 72
<b>Accident time:</b> not recorded	<b>Accident Date:</b> 28/09/1978
<b>Where it occurred:</b> Border minefield, near Mutare	<b>Country:</b> Zimbabwe
<b>Primary cause:</b> Unavoidable (?)	<b>Secondary cause:</b> Inadequate equipment (?)
<b>Class:</b> Missed-mine accident	<b>Date of main report:</b> [No date recorded]
<b>ID original source:</b> none	<b>Name of source:</b> Victim
<b>Organisation:</b> [Name removed]	
<b>Mine/device:</b> M969 AP blast	<b>Ground condition:</b> not recorded
<b>Date record created:</b> 23/01/2004	<b>Date last modified:</b> 23/01/2004
<b>No of victims:</b> 1	<b>No of documents:</b> 1

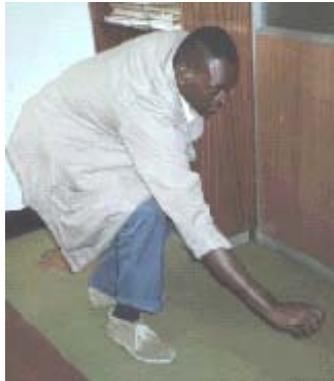
particular area, he placed his foot there and stepped on a mine. The victim believed that rainwater had caused the mine to move from its place in the pattern, and that he missed it whilst prodding. No detectors were available at that time. He was wearing only military dress with no protective clothing or glasses. He did not see his prodder again and so could not comment on how it was damaged.

The victim was bending forward slightly at the time of the accident. (See photograph above.) He lost his right leg below the knee and suffered lacerations to his left leg and both arms.
