# DDAS Accident Report

<b>Report date:</b> 19/04/2006	<b>Accident number:</b> 82
<b>Accident time:</b> not recorded	<b>Accident Date:</b> 19/07/1997
<b>Where it occurred:</b> Kariz Mir Village, Shakar Dara District, Kabul	<b>Country:</b> Afghanistan
<b>Primary cause:</b> Field control inadequacy (?)	<b>Secondary cause:</b> Inadequate equipment (?)
<b>Class:</b> Vegetation removal accident	<b>Date of main report:</b> [No date recorded]
<b>ID original source:</b> none	<b>Name of source:</b> MAPA/UNOCHA
<b>Organisation:</b> [Name removed]	
<b>Mine/device:</b> PMN AP blast	<b>Ground condition:</b> bushes/scrub hard residential/urban
<b>Date record created:</b> 23/01/2004	<b>Date last modified:</b> 23/01/2004
<b>No of victims:</b> 1	<b>No of documents:</b> 1

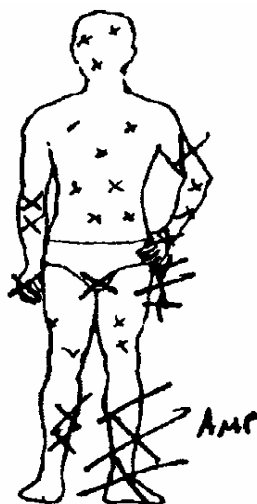
The victim's injuries were summarised as: "left leg amputated and received fatal injuries on his thigh;" traumatic amputation of left leg under knee, serious injury to left thigh, serious injury to testes; injuries to both hands: died on 24<sup>th</sup> July.

A sketch showing extensive injury is reproduced below.

The demining group reported that the victim had suffered a below knee amputation of his left leg, a fracture of his left femur, lacerated wounds to his left gluteal region, left thigh, groin and multiple superficial injuries on both arms. The victim died five days later in Kabul hospital.
