DDAS Accident Report

Report date: 19/04/2006	Accident number: 95
Accident time: not recorded	Accident Date: 31/05/1997
Where it occurred: Ibrahim Khail Village, Gardiz City, Paktia Province	Country: Afghanistan
Primary cause: Field control inadequacy (?)	Secondary cause: Unavoidable (?)
Class: Excavation accident	Date of main report: [No date recorded]
ID original source: none	Name of source: MAPA/UNOCHA
Organisation: [Name removed]	
Mine/device: PMN AP blast	Ground condition: agricultural (abandoned) ditch/channel/trench hard
Date record created: 24/01/2004	Date last modified: 24/01/2004
No of victims: 1	No of documents: 1

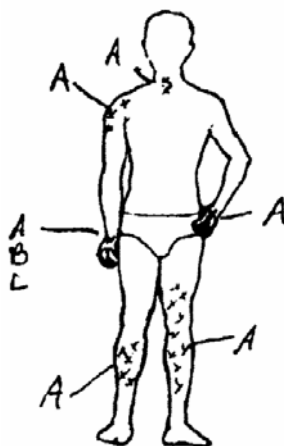
The victim's injuries were summarised as deep lacerations on his right hand, both legs, chin and right shoulder.

A medic's sketch (reproduced above) showed abrasions to his neck, right shoulder, lower right leg, lower and upper left leg and left hand, also abrasions, burns and lacerations to his left hand.
