DDAS Accident Report

Report date: 12/02/2004	Accident number: 113
Accident time: not recorded	Accident Date: 05/01/1997
Where it occurred: Sarpoza, Ward 6, Kandahar City	Country: Afghanistan
Primary cause: Field control inadequacy (?)	Secondary cause: Inadequate training (?)
Class: Excavation accident	Date of main report: [No date recorded]
ID original source: none	Name of source: MAPA/UNOCHA
Organisation: Name removed	
Mine/device: PMN AP blast	Ground condition: building rubble
Date record created: 12/02/2004	Date last modified: 12/02/2004
No of victims: 2	No of documents: 2

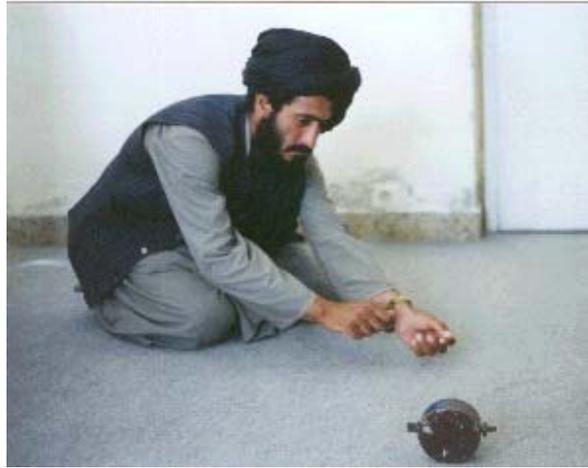
The victim was interviewed by the researcher in Kandahar in July 1998. The photograph below shows him recreating his working position.

He described the accident, saying he was working in a residential area with a back-hoe on site, but he was not checking back-hoe spoil. He removed the back-hoe spoil as instructed and got to the original, undisturbed ground. He checked the original ground where there were many fragments and UXOs with his "Phillips" detector. The detector indicated a reading and he marked the place with three stones and started to use the pick. He mimed his action – swinging in from the side in an attempt to approach the ground at 30°. He thought the PMN mine he hit was on its side. He admitted that he worked all the way to the main detector reading with the pick.

He suffered superficial chest, arm and ear injuries (perforated ear-drum). He was not wearing a fragmentation jacket because no frontal safety equipment was issued (except to the back-hoe observer). He had six weeks off work in total.
