# DDAS Accident Report

<b>Report date:</b> 12/02/2004	<b>Accident number:</b> 113
<b>Accident time:</b> not recorded	<b>Accident Date:</b> 05/01/1997
<b>Where it occurred:</b> Sarpoza, Ward 6, Kandahar City	<b>Country:</b> Afghanistan
<b>Primary cause:</b> Field control inadequacy (?)	<b>Secondary cause:</b> Inadequate training (?)
<b>Class:</b> Excavation accident	<b>Date of main report:</b> [No date recorded]
<b>ID original source:</b> none	<b>Name of source:</b> MAPA/UNOCHA
<b>Organisation:</b> Name removed	
<b>Mine/device:</b> PMN AP blast	<b>Ground condition:</b> building rubble
<b>Date record created:</b> 12/02/2004	<b>Date last modified:</b> 12/02/2004
<b>No of victims:</b> 2	<b>No of documents:</b> 2

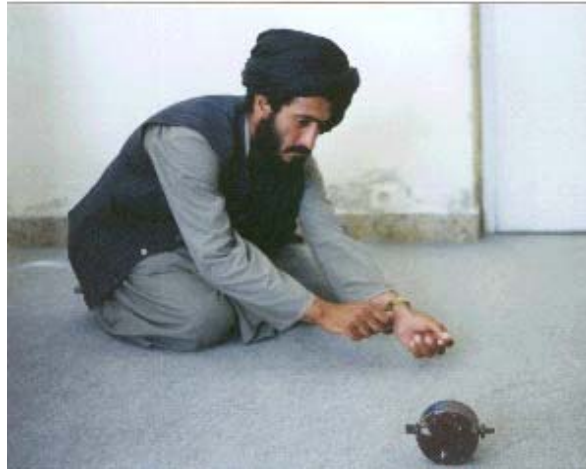
The victim was interviewed by the researcher in Kandahar in July 1998. The photograph below shows him recreating his working position.

He described the accident, saying he was working in a residential area with a back-hoe on site, but he was not checking back-hoe spoil. He removed the back-hoe spoil as instructed and got to the original, undisturbed ground. He checked the original ground where there were many fragments and UXOs with his "Phillips" detector. The detector indicated a reading and he marked the place with three stones and started to use the pick. He mimed his action – swinging in from the side in an attempt to approach the ground at 30°. He thought the PMN mine he hit was on its side. He admitted that he worked all the way to the main detector reading with the pick.

He suffered superficial chest, arm and ear injuries (perforated ear-drum). He was not wearing a fragmentation jacket because no frontal safety equipment was issued (except to the back-hoe observer). He had six weeks off work in total.
