DDAS Accident Report

Report date: 15/05/2006	Accident number: 123
Accident time: 11:15	Accident Date: 25/05/1998
Where it occurred: Boundozi	Country: Afghanistan
Primary cause: Field control inadequacy (?)	Secondary cause: Inadequate training (?)
Class: Excavation accident	Date of main report: [No date recorded]
ID original source: none	Name of source: MAPA/UNOCHA
Organisation: Name removed	
Mine/device: P2Mk2 P4Mk1 AP blast	Ground condition: agricultural (abandoned) hard
Date record created: 12/02/2004	Date last modified: 08/07/2005
No of victims: 1	No of documents: 2

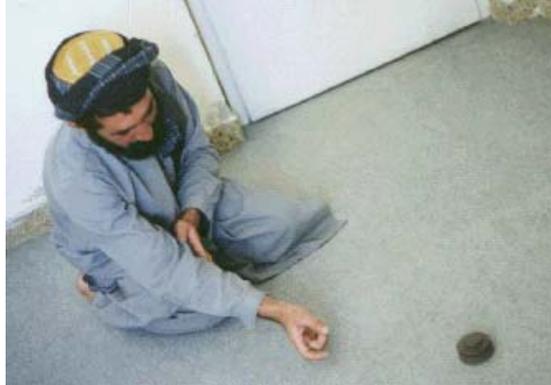
The victim was interviewed in the field (working again after a few weeks) and said he had been a deminer for eight years. The accident occurred while he was excavating a detector reading in a semi-prone position (both knees were on the ground). He got a detector reading (using a "Phillips" detector) and marked the reading with three stones.

He started working from the closest stone to the middle stone with a pick and when he reached the middle marker there was a P2 Mk2(/1) mine under the marker.

The photograph above shows him recreating the position he was in relative to the mine when the accident occurred.

The victim said that he wore his visor, but partly raised.

The investigators recommended that survey teams gather information about mine types accurately, that Team Leaders ensure that deminers lie prone and prod at the right angle while wearing helmets. They recommended that the Section Leader in this case should be disciplined and that Team Leaders should always try to identify the mine type involved in an accident. [The victim identified the mine himself in a later interview – see Related papers.]
