DDAS Accident Report

| Report date: 15/05/2006 | Accident number: 132 |
| Where it occurred: Abas Abad, Kandahar city | Country: Afghanistan |

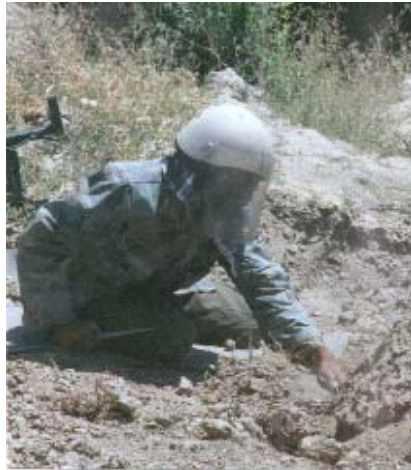
The picture shows a deminer working through back-hoe spoil in Kandahar in 1998. Note his working position, which was raised fully onto his knees as soon as I put the camera away.
