DDAS Accident Report

Report date: 15/05/2006	Accident number: 133
Accident time: not recorded	Accident Date: 23/12/1997
Where it occurred: Kohai Nigar, Ward 6, Kandahar city	Country: Afghanistan
Primary cause: Field control inadequacy (?)	Secondary cause: Unavoidable (?)
Class: Excavation accident	Date of main report: [No date recorded]
ID original source: none	Name of source: MAPA/UNOCHA
Organisation: Name removed	
Mine/device: Fuze	Ground condition: agricultural (abandoned) hard
Date record created: 13/02/2004	Date last modified: 13/02/2004
No of victims: 1	No of documents: 2

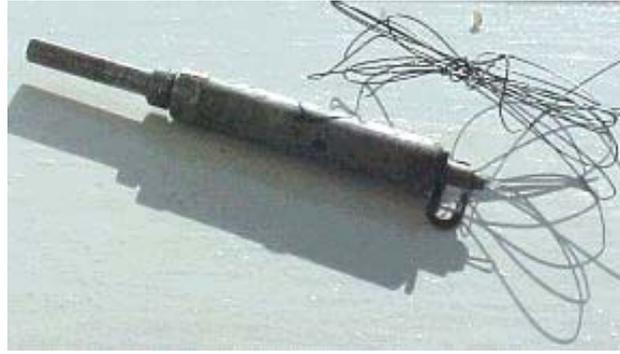
The belief that the device was a "fragment" may be misleading. An MUV fuze complete with detonator is 11cm (4.33") long and constitutes rather a large detector reading.

The picture below is of an MUV fuze and detonator common in Afghanistan. It is possible that pressure applied with a bayonet in the wrong place could dislodge the pin easily – especially if it were already partly pulled. The victim was prodding for something with very different dimensions, so may have been working as trained when the accident occurred.
