# DDAS Accident Report

<b>Report date:</b> 16/05/2006	<b>Accident number:</b> 150
<b>Accident time:</b> not recorded	<b>Accident Date:</b> 07/09/1997
<b>Where it occurred:</b> Qalai Muslim, Ward 7, Kabul city	<b>Country:</b> Afghanistan
<b>Primary cause:</b> Field control inadequacy (?)	<b>Secondary cause:</b> Field control inadequacy (?)
<b>Class:</b> Excavation accident	<b>Date of main report:</b> [No date recorded]
<b>ID original source:</b> none	<b>Name of source:</b> MAPA/UNOCHA
<b>Organisation:</b> Name removed	
<b>Mine/device:</b> PMN AP blast	<b>Ground condition:</b> building rubble hard metal scrap residential/urban
<b>Date record created:</b> 13/02/2004	<b>Date last modified:</b> 13/02/2004
<b>No of victims:</b> 1	<b>No of documents:</b> 1

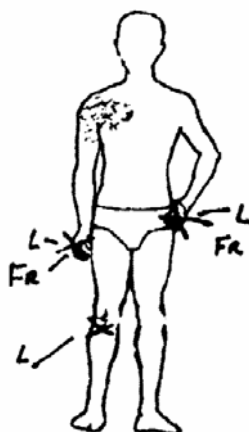
The victim's injuries were summarised as open fractures in the fingers of both hands, penetrative wounds in his right knee and superficial wounds to his right arm and chest.

A medic's sketch (reproduced below) showed fractures and lacerations to his fingers and chest and a shoulder and knee injury.

The demining group reported that the victim had suffered compound fractures of his right thumb and index finger, left index finger, a penetrating wound to his left knee, and superficial wounds to his right arm and chest.
