DDAS Accident Report

Report date: 17/05/2006	Accident number: 155
Accident time: 08:05	Accident Date: 24/03/1999
Where it occurred: Kapfudze village, Mukumbura	Country: Zimbabwe
Primary cause: Field control inadequacy (?)	Secondary cause: Field control inadequacy (?)
Class: Excavation accident	Date of main report: [No date recorded]
ID original source: none	Name of source: KMS
Organisation: Name removed	
Mine/device: R2M2 AP blast	Ground condition: hard
Date record created: 13/02/2004	Date last modified: 13/02/2004
No of victims: 1	No of documents: 2

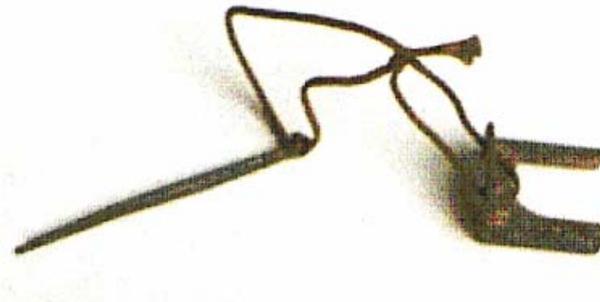
The Site supervisor recommended that the group find alternative methods for investigating signals where the ground was hard or mines deeply buried. He observed that the steel safety clip [galvanised, shown above] was being found away from the mine, so masking the exact location of the mine.

Deminers could start investigating a signal thinking they were 15cm behind a mine and then find that they were actually prodding directly onto it. He recommended that prodding should start 20-25cm behind a signal in future.
