DDAS Accident Report

Report date: 17/05/2006	Accident number: 166
Accident time: 07:40	Accident Date: 28/11/1997
Where it occurred: Mok Heoun, Road 502, Banteay Meanchey Province	Country: Cambodia
Primary cause: Field control inadequacy (?)	Secondary cause: Inadequate equipment (?)
Class: Missed-mine accident	Date of main report: [No date recorded]
ID original source: none	Name of source: CMAC
Organisation: Name removed	
Mine/device: Type 72 AP blast	Ground condition: bushes/scrub electromagnetic grass/grazing area hard
Date record created: 14/02/2004	Date last modified: 14/02/2004
No of victims: 1	No of documents: 2

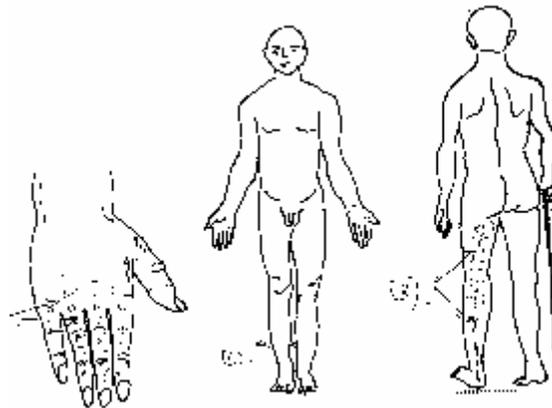
A brief medical report in Khmer was found. It stated that the victim arrived in hospital at 09:15 [conflicting with 09:30 in the Accident report] and that his right leg had been amputated below the knee. His right thigh was also injured and his left leg had suffered scattered fragmentation wounds.

This medical sketch accompanied a compensation claim.
