DDAS Accident Report

Report date: 17/05/2006	Accident number: 175
Accident time: 08:00	Accident Date: 05/12/1996
Where it occurred: Road 696, Banteay Meanchey Province	Country: Cambodia
Primary cause: Field control inadequacy (?)	Secondary cause: Inadequate equipment (?)
Class: Missed-mine accident	Date of main report: [No date recorded]
ID original source: none	Name of source: CMAC
Organisation: Name removed	
Mine/device: AP blast (unrecorded)	Ground condition: bushes/scrub electromagnetic grass/grazing area
Date record created: 14/02/2004	Date last modified: 14/02/2004
No of victims: 2	No of documents: 1

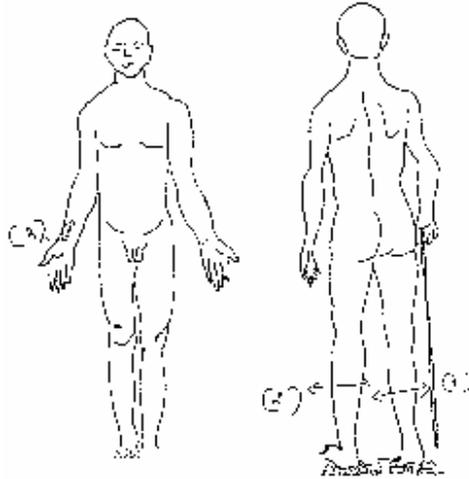
Victim No.1 suffered traumatic amputation of both feet and had a large wound on the underside of his wrist, as indicated on the medical sketch reproduced below.
