# DDAS Accident Report

<b>Report date:</b> 16/04/2004	<b>Accident number:</b> 207
<b>Accident time:</b> 12:55	<b>Accident Date:</b> 01/06/1999
<b>Where it occurred:</b> Between Gajevi and Gornjani villages, RS SAMAC/BRVNIK Region	<b>Country:</b> Bosnia Herzegovina
<b>Primary cause:</b> Management/control inadequacy (?)	<b>Secondary cause:</b> Inadequate training (?)
<b>Class:</b> Missed-mine accident (survey)	<b>Date of main report:</b> 07/06/1999
<b>ID original source:</b> KS/AS/NH/OG/SH/ZP	<b>Name of source:</b> BiH MAC
<b>Organisation:</b> Name removed	
<b>Mine/device:</b> PROM-1 AP Bfrag	<b>Ground condition:</b> agricultural (recent) dry/dusty trees
<b>Date record created:</b> 15/02/2004	<b>Date last modified:</b> 21/02/2004
<b>No of victims:</b> 3	<b>No of documents:</b> 1

The following is the MAC's Accident report, edited for anonymity.

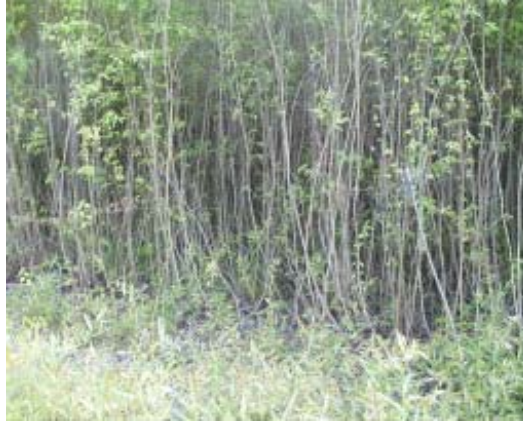
44. Both members of the L1 Survey Group were not equipped with issue footwear. The deceased deminer was wearing lightweight running shoes, as shown on the Photograph at Annex E.
45. Each member of the team was wearing only personal clothing; nothing issued by the MAC.
46. No other protective equipment was worn or carried by the two MAC RO personnel involved.

[The photograph shows the start of the uncut canes.]
