DDAS Accident Report

Report date: 15/05/2006	Accident number: 211
Accident time: 06:40	Accident Date: 31/08/1998
Where it occurred: Nr Route Arizona, 25 Km from Brcko	Country: Bosnia Herzegovina
Primary cause: Field control inadequacy (?)	Secondary cause: Management/control inadequacy (?)
Class: Vegetation removal accident	Date of main report: 04/09/1998
ID original source: WL/WM/IP/NH/SB	Name of source: BiH MAC
Organisation: Name removed	
Mine/device: PROM-1 AP Bfrag	Ground condition: bushes/scrub grass/grazing area rocks/stones route (verge) trees
Date record created: 15/02/2004	Date last modified: 15/02/2004
No of victims: 2	No of documents: 2

BOARD OF INQUIRY REPORT INTO DEMINING ACCIDENT 31 AUGUST 1998

REPORT OF BOARD OF INQUIRY INTO ACCIDENT 31 AUGUST 1998

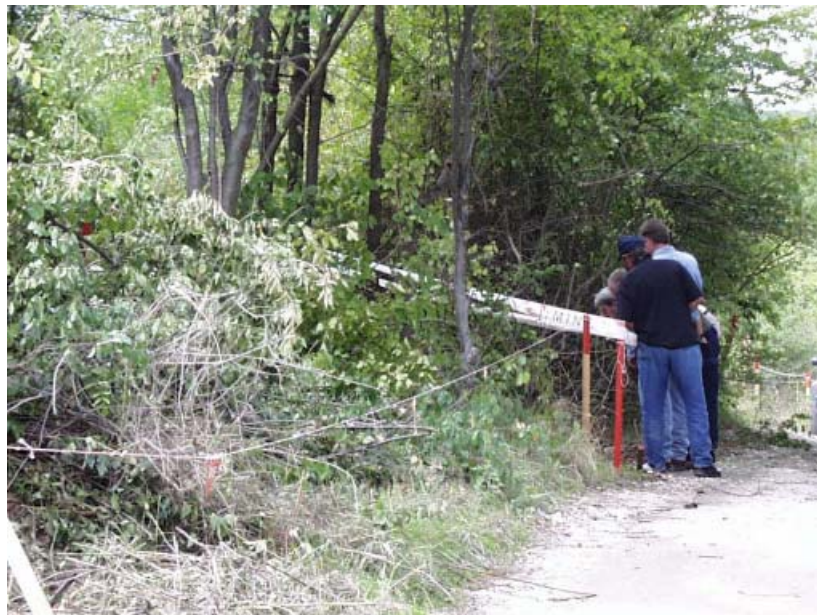
The demining group started work at the site on 20th August 1998 and started work in the accident area on 23rd August 1998. The initial report of the accident from the demining organisation to the country MAC gave the wrong grid reference. At the site, a single Control Point controlled three working areas [presumably at safe working distances along the road verges]. The accident occurred on a verge beside a road. The report describes the verge as "thickly vegetated" with "grass, weeds and small bushes and trees". [A photograph showed tall, largely dry vegetation of sticks and grasses with occasional thin 4-15cm trees.] The deminers had been using a chainsaw to cut undergrowth, including small trees, despite the tool's prohibition.

[The picture above shows the accident site.]

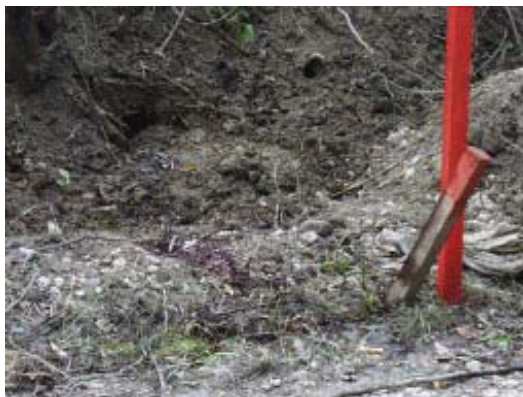
[The picture shows the mine crater.]

41. The mine involved was a PROM-1, bounding Anti Personnel fragmentation mine. This was confirmed by the discovery of the mine's base-plate in the bottom of the crater. Photographs of the crater are shown at Annex E.

44. The mine was laid vertically, in a conventional manner, approximately two metres from the side of the road. A conventional tripwire, of the type issued with PROM-1 mines was laid next to the crater. It is the opinion of the board that this tripwire was originally laid with the mine. It is not clear whether the mine was activated via the tripwire or directly through pressure on the top of the fuze.

45. Evidence from the clearance lane shows that the deminer who was killed in this accident was not more than half a metre away from the mine when it detonated.
