# DDAS Accident Report

<b>Report date:</b> 15/05/2006	<b>Accident number:</b> 223
<b>Accident time:</b> 13:55	<b>Accident Date:</b> 09/10/1997
<b>Where it occurred:</b> Lime Factory, Sevarlije, Doboј	<b>Country:</b> Bosnia Herzegovina
<b>Primary cause:</b> Management/control inadequacy (?)	<b>Secondary cause:</b> Management/control inadequacy (?)
<b>Class:</b> Missed-mine accident	<b>Date of main report:</b> 27/10/1997
<b>ID original source:</b> MG/WL	<b>Name of source:</b> BiH MAC
<b>Organisation:</b> Name removed	
<b>Mine/device:</b> PMA-2 AP blast	<b>Ground condition:</b> bushes/scrub metal scrap rocks/stones route (verge) trees
<b>Date record created:</b> 17/02/2004	<b>Date last modified:</b> 17/02/2004
<b>No of victims:</b> 1	<b>No of documents:</b> 2

REPORT ON 9 OCTOBER 97 MINE ACCIDENT NEAR LIME FACTORY, DOBOJ

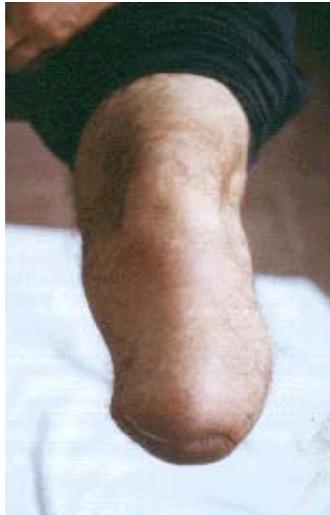
On 11<sup>th</sup> November he was moved to a military hospital and on 13<sup>th</sup> November they surgically amputated his leg removing "some small bone" probably three centimetres. Because much of his calf muscle was still intact, they could wrap his stump without grafting.

He allowed his stump to be photographed as shown above.
