DDAS Accident Report

Report date: 18/05/2006	Accident number: 227
Accident time: 12:30 approx	Accident Date: 19/07/1997
Where it occurred: Sevarlije, Doboј	Country: Bosnia Herzegovina
Primary cause: Management/control inadequacy (?)	Secondary cause: Field control inadequacy (?)
Class: Missed-mine accident	Date of main report: 23/07/1997
ID original source: WL/EB/VT	Name of source: BiH MAC
Organisation: Name removed	
Mine/device: PMA-3 AP blast	Ground condition: agricultural (abandoned) bushes/scrub grass/grazing area trees
Date record created: 17/02/2004	Date last modified: 17/02/2004
No of victims: 1	No of documents: 2

REPORT ON MINE ACCIDENT AT SEVARLIJE, NEAR DOBOJ

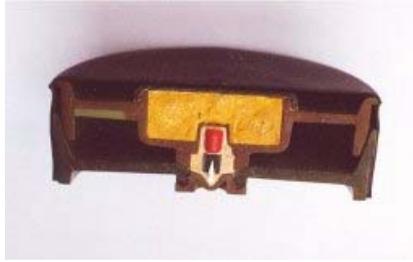
The injuries resulting from stepping on a PMA-3 vary from traumatic amputation to minor bruising. The picture below shows why this can happen. It shows a cut-away section through a PMA-3. The 35g Tetryl is in the top and centre of the mine. The area of pressure-plate surrounding the HE is actually larger than the area of pressure-plate over it. If a victim is fortunate, they step on the pressure plate but the explosive charge is not beneath their foot.

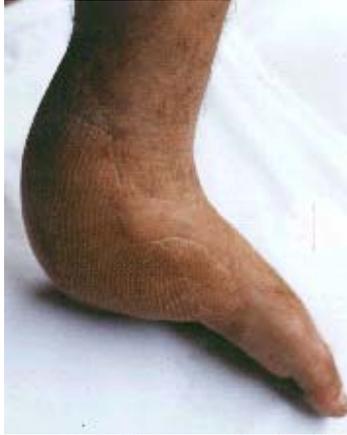
At hospital they took "X" rays of his foot and operated. He had a small hole "finger sized" in his heel and the skin was damaged on one side. He said the bone inside was smashed. His right lower arm was peppered with fragments (he showed the scars). They removed stones from his arm when they cleaned the wounds which healed very quickly. The foot was terribly painful. After they operated he woke up with a splint on his leg holding his foot at a right angle and leaving the wound open.

He needed a prosthetic shoe to walk but it was still painful and his "leg shakes inside". The demining company gave him his first shoe but even with it he could not carry anything when walking and could not walk very far. When interviewed, his original prosthetic shoe had worn out and no longer fitted the wound. He said that his injured leg was shorter [hard to measure with the heel absent] and that it swelled when he used it. He said that he wished they had cut off his foot and given him a lower leg prosthetic and compensation. Then he could have got on with his life.

The victim's foot was photographed during the interview.
