DDAS Accident Report

Report date: 18/05/2006	Accident number: 228
Accident time: not recorded	Accident Date: 19/07/1997
Where it occurred: Sevarlije, Doboј	Country: Bosnia Herzegovina
Primary cause: Management/control inadequacy (?)	Secondary cause: Field control inadequacy (?)
Class: Missed-mine accident	Date of main report: 23/07/1997
ID original source: WL/EB/VT	Name of source: BiH MAC
Organisation: Name removed	
Mine/device: PMA-3 AP blast	Ground condition: agricultural (abandoned) bushes/scrub grass/grazing area trees
Date record created: 17/02/2004	Date last modified: 17/02/2004
No of victims: 1	No of documents: 2

REPORT ON MINE ACCIDENT AT SEVARLIJE, NEAR DOBOJ

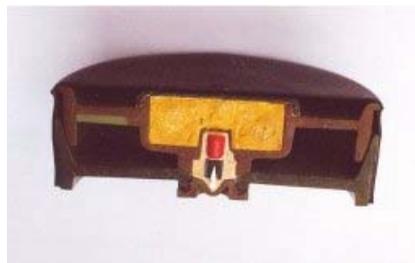
The injuries resulting from stepping on a PMA-3 vary from traumatic amputation to minor bruising. The picture below shows why this happens. It shows a cut-away section through a PMA-3. The 35g Tetryl is in the top and centre of the mine. The area of pressure-plate surrounding the HE is actually larger than the area of pressure-plate over it. If a victim is fortunate, they step on the pressure plate but the explosive charge is not beneath their foot.
