DDAS Accident Report

Report date: 18/05/2006	Accident number: 240
Accident time: 08:40	Accident Date: 24/03/1998
Where it occurred: Chawni, Jali district, Paktia Province	Country: Afghanistan
Primary cause: Field control inadequacy (?)	Secondary cause: Inadequate equipment (?)
Class: Excavation accident	Date of main report: [No date recorded]
ID original source: none	Name of source: MAPA/UNOCHA
Organisation: Name removed	
Mine/device: PMN AP blast	Ground condition: hard metal scrap
Date record created: 17/02/2004	Date last modified: 17/02/2004
No of victims: 1	No of documents: 1

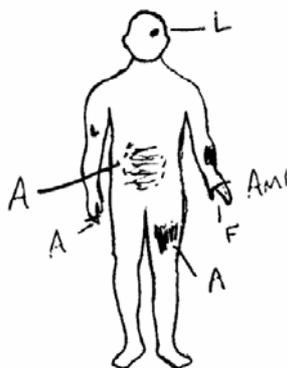
The field medical report stated that the victim had lost vision in his left eye, suffered traumatic amputation of his left thumb and index finger, fractured/dislocated his left wrist and elbow, suffered laceration and bruising to right hand and abdomen.

A medic's sketch is reproduced below.
