DDAS Accident Report

Report date: 18/05/2006	Accident number: 252
Accident time: 09:35	Accident Date: 15/10/1998
Where it occurred: Bala Deh, Kandahar city	Country: Afghanistan
Primary cause: Field control inadequacy (?)	Secondary cause: Inadequate equipment (?)
Class: Excavation accident	Date of main report: [No date recorded]
ID original source: none	Name of source: MAPA/UNOCHA
Organisation: Name removed	
Mine/device: PMN AP blast	Ground condition: hard residential/urban
Date record created: 18/02/2004	Date last modified: 18/02/2004
No of victims: 1	No of documents: 1

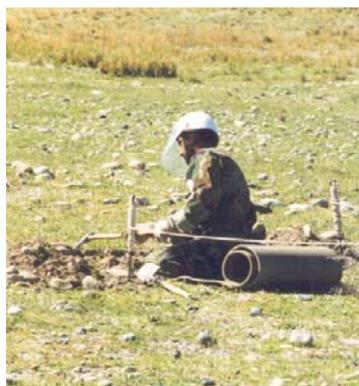
The investigators failed to mention that the victim was not working in the prone position, presumably because the way they had been trained to use a pick was in a squatting/kneeling position (it cannot realistically be used when prone). The picture below shows an Afghan deminer of the period using a pick in a manner observed as typical.
