DDAS Accident Report

Report date: 15/03/2004	Accident number: 263
Accident time: 10:00	Accident Date: 30/11/1999
Where it occurred: One km west of Ladrovac village, Suva Rica, MNB South	Country: Kosovo
Primary cause: Other (?)	Secondary cause: Other (?)
Class: Missed-mine accident (survey)	Date of main report: 02/12/1999
ID original source: KC/MD/JF	Name of source: KMACC
Organisation: Name removed	
Mine/device: PMA-2 AP blast	Ground condition: leaf litter route/path woodland
Date record created: 18/02/2004	Date last modified: 03/03/2004
No of victims: 1	No of documents: 3

Accident report

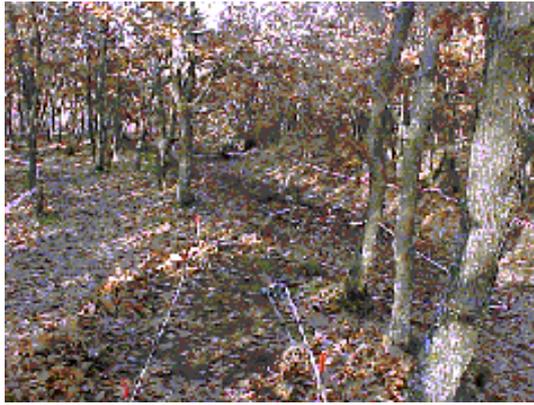
- The accident place was marked with red and white chevron plastic tape on both sides.
 - There were no mine signs visible at this time.
 - Local population frequently used the track.

[The picture below shows the accident site during the investigation when extra tapes were in place.]

8. The demining group's staff then erected mine signs at the entrance to the track. The entrance was also marked with mine tape. In the opinion of the Operations Manager, there was no requirement to forensically seal any mine/UXO clearance equipment as no mine/UXO clearance activity was being undertaken at the time of the accident.

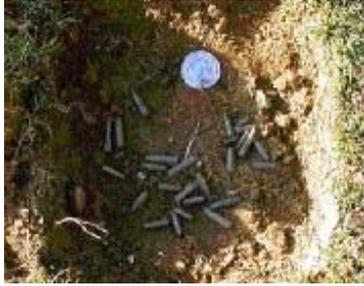
15. A substantial amount of metal was found in the area marked as safe. [One of the scrap-areas is shown in the picture above.]
16. On arrival to the MACC HQ, verification was done in the weekly report to identify which organisation had been working in that area. It was found that Group C had teams working exactly in this area during the week of 1- 6 November 1999.
17. On the morning of the 2 November the Programme Manager from Group C came to MACC HQ to clarify what had happened and to explain what his group intended to do with this dangerous area. In the afternoon, he came back with the expatriate in charge of the team that did the marking at the accident site and they gave a brief explanation of what had occurred three weeks before.
