DDAS Accident Report

Report date: 23/03/2004	Accident number: 266
Accident time: 17:05	Accident Date: 20/04/00
Where it occurred: Nr Kraljane, MNBW district, Gjavoka municipality	Country: Kosovo
Primary cause: Management/control inadequacy (?)	Secondary cause: Inadequate training (?)
Class: Detection accident	Date of main report: 03/05/2000
ID original source: MD/KC/JF	Name of source: KMACC
Organisation: Name removed	
Mine/device: PMA-3 AP blast	Ground condition: bushes/scrub woodland (light)
Date record created: 18/02/04	Date last modified: 23/03/04
No of victims: 1	No of documents: 3

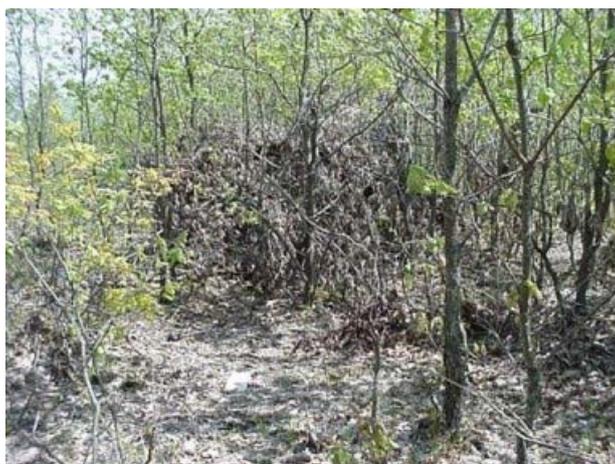
The picture above shows the mined area beyond the accident site.

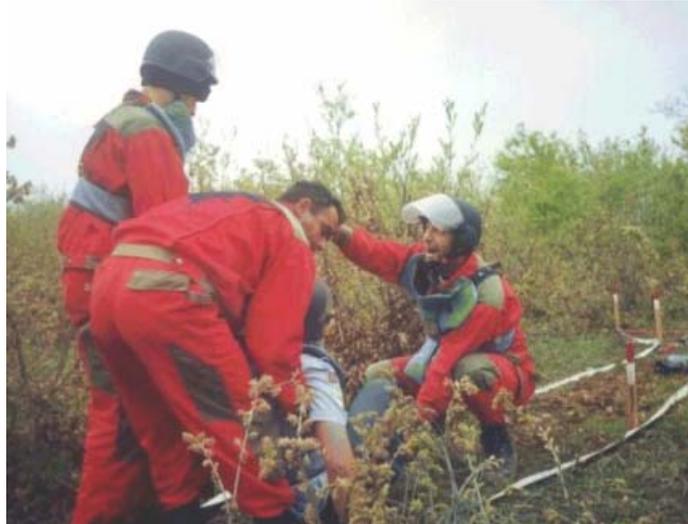
The victim stated that he had swept the area where the mine detonated and got no reading. It is not recorded how the victim reached the safe lane. Within seconds, two deminers and two supervisors were helping him in the one meter wide safe lane. The photograph below was taken as the victim was being evacuated. The investigators called it a "bad example of command and control" because the "one metre wide lane is overcrowded and offers potential for further injuries. Visors were also not worn and worn raised.

The photographs of the rescue team crowded in a narrow lane with visors raised was a further example of inadequate Field management.

The investigators recommended that the demining group's management take disciplinary action against the victim, carry out CASEVAC exercises for victim "extraction" as soon as possible and review their methods of testing the detector to include using a test-piece buried in soil.

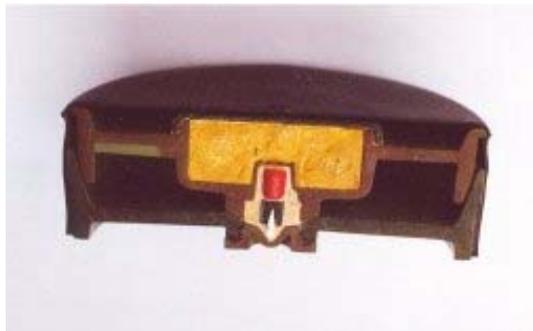
The PMA-3 blast mine contains a very small high explosive charge. This accident illustrates how the results of stepping on a PMA-3 can be a lottery. This may be because of the design of the mine or because its depth sometimes allows energy to dissipate prior to impact with the foot. Crater depth in this case may have provided a clue – especially because the crater resulting from the previous accident at the site had been photographed – so the failure to record the crater in this accident is regrettable.

The injuries resulting from stepping on a PMA-3 vary from bruising to traumatic amputations. The picture below shows why this happens. It shows a cut-away section through a PMA-3. The 35g Tetryl is in the top and centre of the mine. The area of pressure-plate surrounding the HE is actually larger than the area of pressure-plate over it. If a victim is fortunate, they step on the pressure plate but the explosive charge is not beneath their foot.
