DDAS Accident Report

Report date: 18/05/2006	Accident number: 271
Accident time: 11:35	Accident Date: 28/07/2000
Where it occurred: Nr Kralijane, SE of Peje	Country: Kosovo
Primary cause: Management/control inadequacy (?)	Secondary cause: Inadequate training (?)
Class: Missed-mine accident	Date of main report: 08/08/2000
ID original source: KC/PS/JF	Name of source: KMACC
Organisation: Name removed	
Mine/device: PMA-3 AP blast	Ground condition: bushes/scrub woodland (light)
Date record created: 18/02/2004	Date last modified: 17/03/2004
No of victims: 2	No of documents: 2

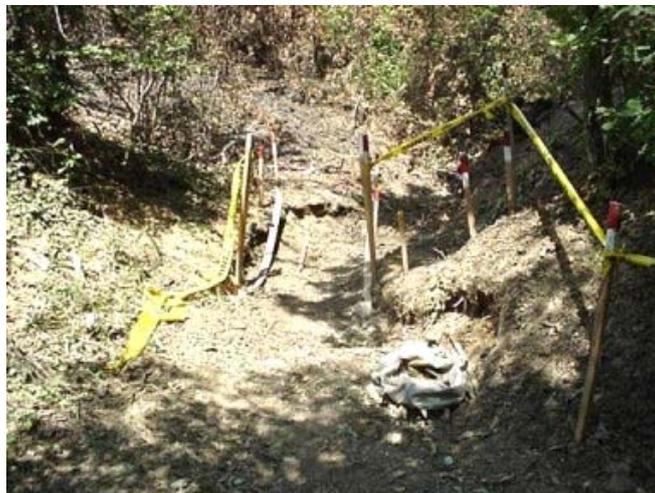
At 11:35 Victim No.1 moved to edge of the cleared area to look at the mine he had seen and trod on a PMA-3 inside the area marked as cleared. "The victim walked/ran by himself to a safe area" where other deminers made him lie down and calmed him. The medics arrived and Victim No.1 was carried to the ambulance. He left for the Argentine KFOR hospital at 11:45 and arrived as 12:10. He was conscious at all times. The hospital released him "Later in the afternoon".

The photograph below shows the accident site.

The investigators found that the site was not laid out in accordance with the group's SOPs and the access lane was only one meter wide instead of two. The demining group's SOPs were also not followed over "the use of the base stick" and this caused the mine to be missed.

The investigators recommended that the demining group "review their training programme for deminers and supervisors" as a result of this and previous accidents. Refresher courses for deminers and supervisors must be given, and should cover the behaviour of a casualty in the event of an accident. The demining group was recommended to take "appropriate disciplinary action" against personnel in breach of SOPs.

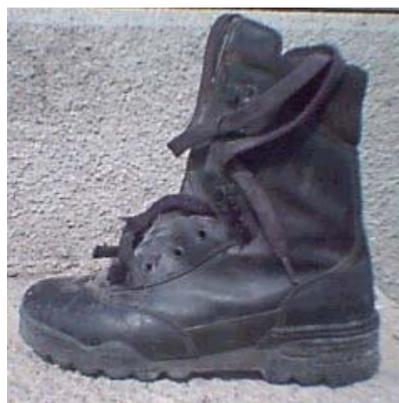
Photographs of Victim No.1's PPE and boot showed that the visor was dusty and the boot apparently undamaged apart from broken laces (which may have been cut to remove it).

The photograph alongside shows the victim's boot after the accident. It is not clear whether the laces were cut by the medics or broke in the explosion.
