-DDAS Accident Report

Report date: 19/05/2006	Accident number: 304
Accident time: 14:20	Accident Date: 10/10/1999
Where it occurred: Suleimanya province, Sharbazher district, Mawat sub-district, Awakutie village	Country: Iraq
Primary cause: Field control inadequacy (?)	Secondary cause: Inadequate training (?)
Class: Handling accident	Date of main report: [No date recorded]
ID original source: NPA/ET	Name of source: ET/AVS 2001:KI01
Organisation: Name removed	
Mine/device: Fuze	Ground condition: not recorded
Date record created: 19/02/2004	Date last modified: 19/02/2004
No of victims: 1	No of documents: 1

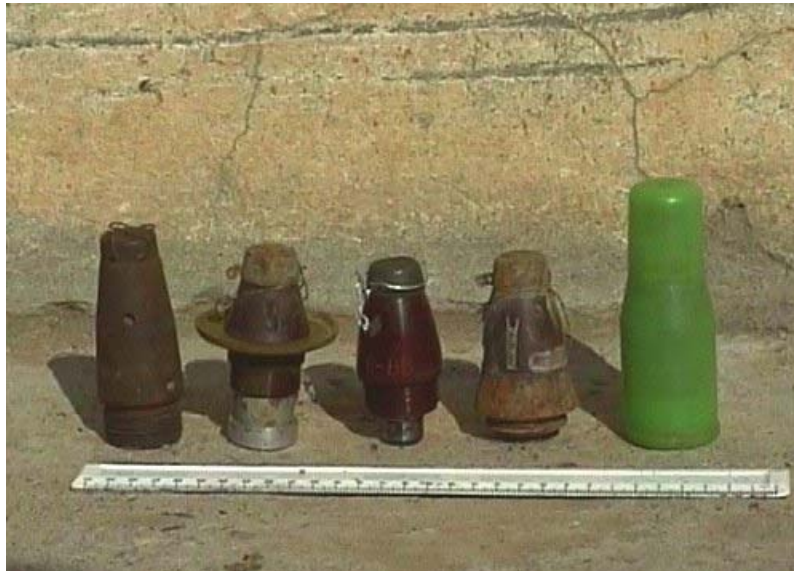
A battle Area Clearance (BAC) team was working in an area where the task comprised approximately 500 mortar bombs and shells. Most of the items were visible on the surface. People nearby had been interfering with the items trying to take them apart. The accident occurred when an EOD worker was making a final check over the cleared area. He then discovered a partly buried mortar (PD M-6) fuze. The fuze was already taken apart. The booster was removed and no safety pins (two) were in place. When the EOD worker handled the fuze the striker "sledged and initiated the detonator".

The picture above was provided by the demining group and shows some of the fuzes they had encountered at the site.

The primary cause of this accident is listed as a "*Field control inadequacy*" because it is assumed that the victim should not have handled a damaged fuze. The fact that it was found on a final check implies that it may have been missed earlier and raises questions about the methods used. If the victim did not know that it was dangerous to handle a damaged fuze, his training was inadequate. The secondary cause is listed as "*Inadequate training*".
