DDAS Accident Report

Report date: 19/05/2006	Accident number: 314
Accident time: 13:00	Accident Date: 07/06/2000
Where it occurred: Power lines North of Rio Ligonha, Nampula Province	Country: Mozambique
Primary cause: Unavoidable (?)	Secondary cause: Inadequate equipment (?)
Class: Excavation accident	Date of main report: 09/06/2000
ID original source: GZ/AVS2001:MZ03	Name of source: HT (field): IND 132
Organisation: Name removed	
Mine/device: M969 AP blast	Ground condition: hard metal fragments pylons and surrounds
Date record created: 20/02/2004	Date last modified: 29/02/2004
No of victims: 1	No of documents: 1

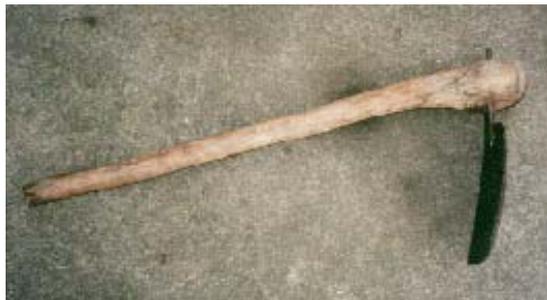
The deminer was obliged to use a full excavation method in hard ground using an enxada.

The use of some kind of pick-axe or hoe is not unusual when conducting area-excavation. The tool is swung in at a low angle and used to shave the face of the excavation in a slow advance. This is the second of three accidents involving this demining NGO and an enxada in Mozambique. See the accidents on 14th April 1998 and on 7th July 2000.

A photograph of an enxada is shown above.
