DDAS Accident Report

Report date: 15/03/2004	Accident number: 315
Accident time: 10:45	Accident Date: 24/12/1999
Where it occurred: Tower 88, Moamba District, Maputo Province	Country: Mozambique
Primary cause: Victim inattention (?)	Secondary cause: Inadequate equipment (?)
Class: Vegetation removal accident	Date of main report: 29/12/1999
ID original source: MT/AR	Name of source: CND/IND/MT
Organisation: Name removed	
Mine/device: PMN AP blast	Ground condition: bushes/scrub grass/grazing area pylons and surrounds sparse trees wet
Date record created: 20/02/2004	Date last modified: 20/02/2004
No of victims: 1	No of documents: 1

The accident occurred at 10:45 on December 24th 1999 during the manual demining of power lines between Maputo and Komatiport at the 88th tower about 8km from Moamba Town. The area being cleared was very muddy with lots of shrubs and grass around the pylon.

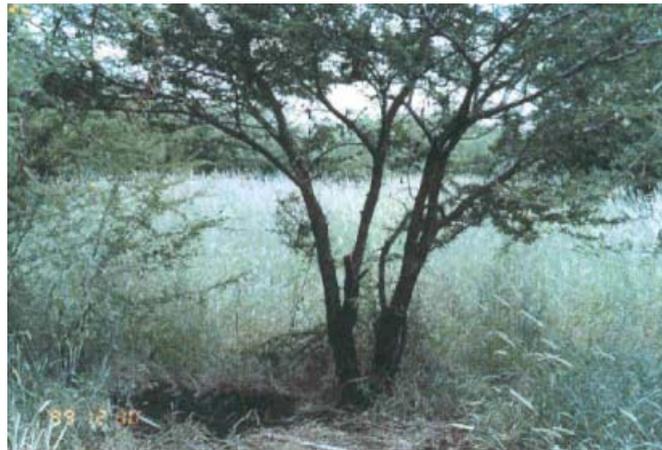
The deminer was injured in an area considered to be densely mined during an attempt to enlarge the cleared area from 20 square metres to 40 square metres. While trying to cut some shrubs he made a "false move" and activated a mine outside his lane with his left foot. The mine was outside the "ring" and below a tree.

A photograph of the accident site is shown above.

The accident was unavoidable due to the squatting posture of the victim when he was working, which did not give him much room for movement. The one movement he made to make more room for work resulted in the accident.

The most serious injuries caused by the mine were mainly due to the demining group not providing their deminers with protective vests.

Pressure put on the deminers to finish the lane in "record time" and "obliging" them to work as volunteers are one of the factors which contributed to the accident.

The demining group must put in place measures which guarantee the safety of deminers. In this regard they have to introduce the mandatory use of protective vests.

From now on, the demining group must acquire an ambulance and not use alternative vehicles, as was the case in this instance.
