DDAS Accident Report

Report date: 15/03/2004	Accident number: 328
Accident time: 09:15	Accident Date: 31/10/2000
Where it occurred: Nr Jasiq village, MNB West	Country: Kosovo
Primary cause: Field control inadequacy (?)	Secondary cause: Unavoidable (?)
Class: Missed-mine accident	Date of main report: 07/11/2001
ID original source: MD/CC/JF	Name of source: KMACC
Organisation: Name removed	
Mine/device: PMA-2 AP blast	Ground condition: grass/grazing area rocks/stones sparse trees
Date record created: 20/02/2004	Date last modified: 20/02/2004
No of victims: 1	No of documents: 3

Accident report

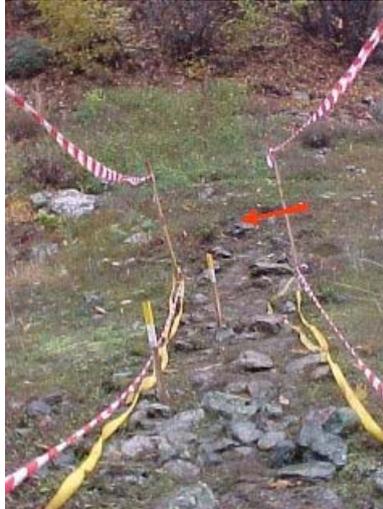
The photograph above shows the clearance lane where the accident occurred.

[The red arrow indicates the rock beyond which the blast occurred: notice how far ahead of the lane marking it is. See paragraph 19 in which the investigator reports that the base stick was 4 metres ahead of the marking. The investigator wrote that he was standing on a rock in a “cleared area”, but there is no obvious excavation leading to the site so it seems that he was actually standing in an uncleared area trying to locate the next mine by eye. The next mine was visible – a photograph of its pressure-star was included in the report.]

19. [The Victim] was not using any equipment at the time of the accident. However he was carrying a small pair of vegetation cutters in his right hand. Both the vegetation cutters and the two parts of the broken base stick were located in front of the blast hole in the uncleared area. The base stick [shown below] is broken in two and was approximately 4 meters inside the uncleared area.

When demining in a rocky area all rocks must be moved out of the clearance lane. It is clear that the mine was concealed in a manner not consistent with other mines found in the area. Therefore, additional suspicion must be given when dealing with rocky ground. This will be added to the SOP.
