DDAS Accident Report

Report date: 17/03/2004	Accident number: 341
Accident time: 08:30	Accident Date: 29/08/2000
Where it occurred: Jahorina, Palosevina	Country: Bosnia Herzegovina
Primary cause: Field control inadequacy (?)	Secondary cause: Field control inadequacy (?)
Class: Excavation accident	Date of main report: 01/09/2000
ID original source: AS/AA/BK	Name of source: BiH MAC
Organisation: Name removed	
Mine/device: PMA-3 AP blast	Ground condition: grass/grazing area metal fragments pylons and surrounds rocks/stones
Date record created: 21/02/2004	Date last modified: 17/03/2004
No of victims: 1	No of documents: 2

The following is the MAC's Accident report, edited for anonymity.

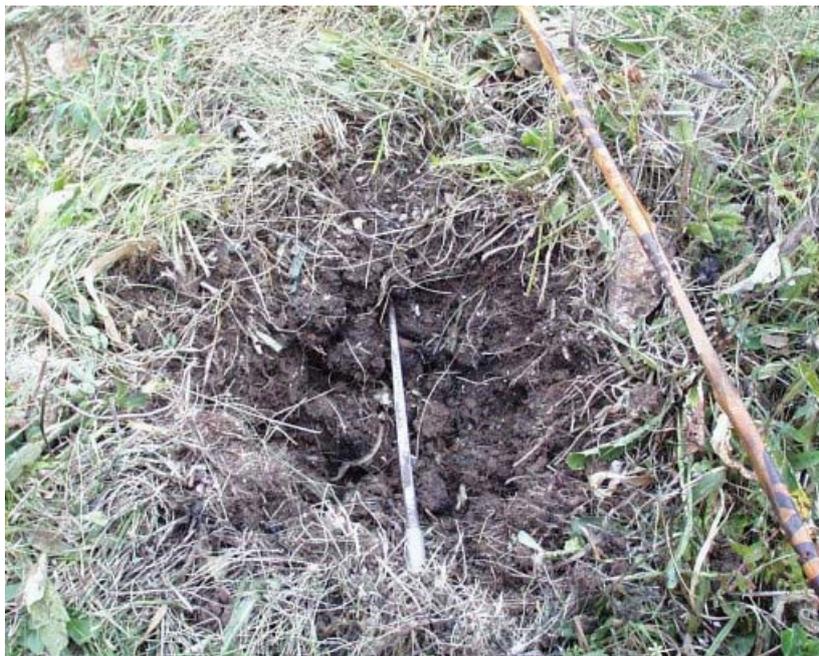
[The Victim's long prod is shown above - in the blast crater.]

Explosive device that caused the accident was a PMA-3 mine. The plastic parts of its bottom were found in the explosion crater. The ring-shaped rubber that connects the halves as well as the parts of the plastic ring of the handle with a spring were found to the right side, backwards for about one metre from the crater with the very edge of the left side of the box, which is clearly seen on photos No 7 and 8, Annex E.

According to the parts of the mine found, especially the rubber part, it is clear that the branch of the explosion blast was directed to the face and upper right part of the body towards the shoulder. This is clearly seen on the protective jacket, which was taken off by the medic during providing the first emergency aid. Regarding the very location of the crater, where the soil is in a mild slope, it is possible that the mine in the soil was placed leaned backwards and slightly to the right. From what is stated above, it is probable that the angle of the prod was more than 30° related to the position of the mine. Due to relatively hard surface, the prod was probably harder, with no sense of touching the rubber. That activated the mine. It can be stated that even less force was needed for the activation of the mine since it was laid in the ground and remained there from 1992. According to the data provided on this mine (JNA manuals), it is reliable regarding its primary characteristics for since months if in the ground. Since the mine's top part gets older and stains, the mine is losing its stability. Therefore, less force is needed for the activation of these mines, which was also proved by the mechanical preparation of the ground, when almost 90% of those mines were not activated.

The critical mine activated by [the Victim] WAS underneath the big rock thrown on the ground during the bombing. The rock mentioned did not activate the mine due to its large leaning surface.

It is possible to activate a PMA-3 in the hard surface since it is hard to make a difference when touching the rubber part with the prodder. It is what the demining work consists of. In this particular case, it was easier to activate the mine due to the slope of the ground, the position of the mine as well as the length of time it actually was in the ground. This means that it did not require the same force of prodding in comparison to the period of 6 months when it is laid and reliable regarding its activation characteristics.

When using manual methods in areas with rock scattered over, rocks are to be gently removed (taken up or pulled if bigger) to the safe areas, which would totally remove the mine threat regarding the possibility of a mine left under a stone / rock scattered during bombing over mined areas.
