# DDAS Accident Report

<b>Report date:</b> 16/03/2004	<b>Accident number:</b> 342
<b>Accident time:</b> 13:05	<b>Accident Date:</b> 23/08/2000
<b>Where it occurred:</b> Jahorina, Palosevina	<b>Country:</b> Bosnia Herzegovina
<b>Primary cause:</b> Field control inadequacy (?)	<b>Secondary cause:</b> Field control inadequacy (?)
<b>Class:</b> Missed-mine accident	<b>Date of main report:</b> 28/08/2000
<b>ID original source:</b> NH/AA/ZV	<b>Name of source:</b> BiH MAC
<b>Organisation:</b> Name removed	
<b>Mine/device:</b> PMA-3 AP blast	<b>Ground condition:</b> grass/grazing area metal fragments rocks/stones soft
<b>Date record created:</b> 21/02/2004	<b>Date last modified:</b> 21/02/2004
<b>No of victims:</b> 1	<b>No of documents:</b> 2

## **Accident report**

## LESSON LEARNED – DEMINING ACCIDENT AUGUST 23<sup>rd</sup> 2000

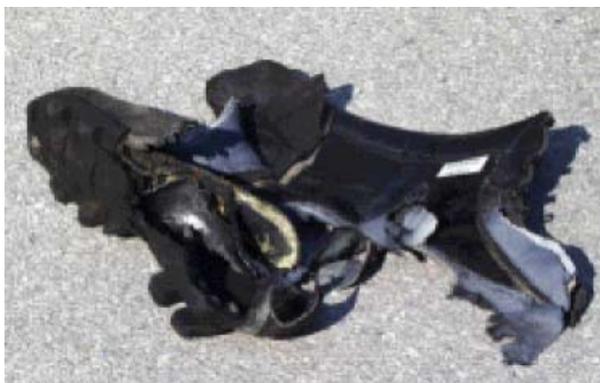
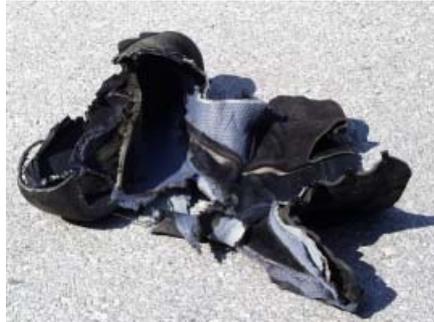
[The Victim's boot is shown above. It is a Welco blast boot designed to be worn with overboots. The overboots were not worn in this instance. These pictures were not included in the original report.]

The use of the Welco blast boot (a donation to the region) did not reduce the Victim's injuries. A MAC representative reported that it could not be worn with the overboot (as designed) because of the uneven terrain. This full boot (with overboot) have been shown to be of some protection when stepping on a mine as small as a PMA-3. However, it has not been shown to be of any value when stepping on the PMA-1 or PMA-2 mines that are also common in the region. Source: US Army Communications - Electronics Command Night Vision Electronic Sensors Directorate, Fort Belvoir, VA 22060-5806 - Final Report of the Lower Extremity Assessment Program (LEAP - 99-2), August 2000 - carried out by the US Army Institute of Surgical Research, Extremity Trauma Study Branch, Fort Sam Houston, TX 78234-6315

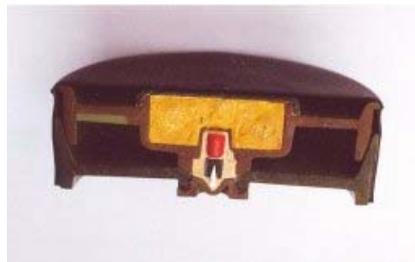
The injuries resulting from stepping on a PMA-3 in ordinary footwear vary from traumatic amputation to minor bruising. The picture below shows why this happens. It shows a cut-away section through a PMA-3. The 35g Tetryl is in the top and centre of the mine. The area of pressure-plate surrounding the HE is actually larger than the area of pressure-plate over it. If a victim is fortunate, they step on the pressure plate but the explosive charge is not beneath their foot.
