DDAS Accident Report

Report date: 19/05/2006	Accident number: 349
Accident time: 09:45	Accident Date: 11/07/1999
Where it occurred: Sizje village, Lukavac municipality	Country: Bosnia Herzegovina
Primary cause: Field control inadequacy (?)	Secondary cause: Management/control inadequacy (?)
Class: Missed-mine accident	Date of main report: 15/07/1999
ID original source: RB/JG/NK/MB/VMM	Name of source: BiH MAC
Organisation: Name removed	
Mine/device: PROM-1 AP Bfrag	Ground condition: building rubble bushes/scrub metal scrap
Date record created: 21/02/2004	Date last modified: 21/02/2004
No of victims: 4	No of documents: 1

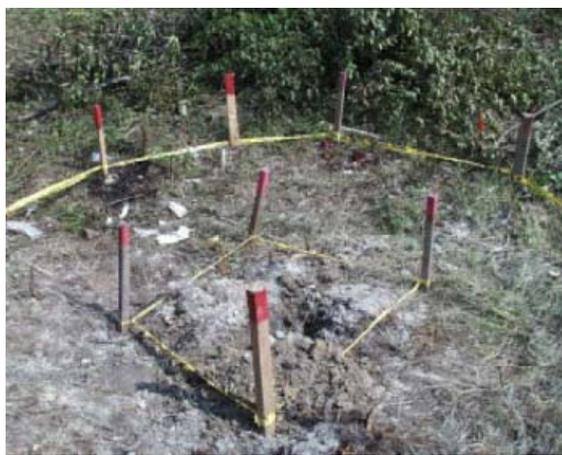
[The photograph above shows the accident site after the detonation.]

12.1 It was possible to recover the base plate of the mine in the crater at the depth of 25 cm.

12.4 The oval crater made by explosion was 35 x 20cm in dimensions. (Annex K – Photography – base plate and the copper tube). [Not made available.]

17.1 The accident occurred at a distance of 18.2m from the road – datum line, in the “cleared” area where the vegetation was very thoroughly removed by vertical cutting – using an axe. Accident happened when the sign for the break was given, while the deminers were leaving the minefield towards the Control point.

17.2 The cause of the accident is the PROM –1 mine activated with pressure.

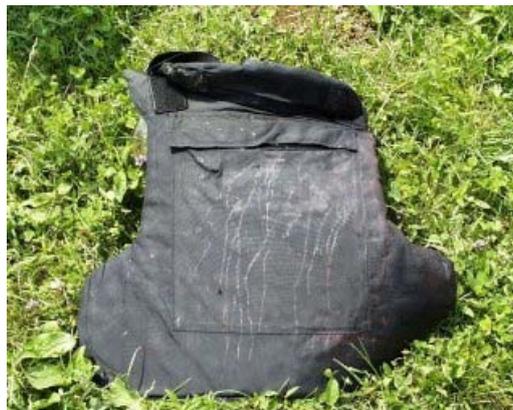
[The photograph above shows the medic’s frag-vest.]

9.4.2 [Victim No.4], the medic, was injured in his left arm so that two arteries were cut by a splinter.

14.0 Deminers were not wearing PPE when the accident occurred. None of the deminers' vests or helmets were damaged or stained with blood. Only the injured medic was wearing his PPE, which is damaged and stained with blood, but it stopped the medic from being injured even more severely.

No one is to be allowed to leave the Control Point or enter the minefield without a proper PPE, whether those were operating deminers or others.
