DDAS Accident Report

Report date: 19/05/2006	Accident number: 350
Accident time: 08:45	Accident Date: 15/07/1999
Where it occurred: Kratine, Gola Kosa village, Near Vitez	Country: Bosnia Herzegovina
Primary cause: Unavoidable (?)	Secondary cause: Inadequate training (?)
Class: Handling accident	Date of main report: 22/07/1999
ID original source: EB/RB/VM	Name of source: BiH MAC
Organisation: Name removed	
Mine/device: Fuze	Ground condition: agricultural (abandoned) bushes/scrub soft trees
Date record created: 21/02/2004	Date last modified: 21/02/2004
No of victims: 1	No of documents: 1

Accident report

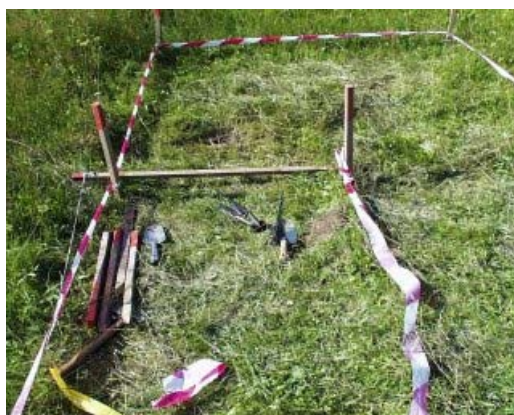
a) The accident site is some 40 metres from the track in a sparsely vegetated field

[The accident site is shown above. It is not obvious how the vegetation was cut so far ahead of the base stick.]
