# DDAS Accident Report

<b>Report date:</b> 15/03/2004	<b>Accident number:</b> 366
<b>Accident time:</b> 10:15	<b>Accident Date:</b> 16/11/2001
<b>Where it occurred:</b> Stajke Village	<b>Country:</b> Kosovo
<b>Primary cause:</b> Inadequate equipment (?)	<b>Secondary cause:</b> Unavoidable (?)
<b>Class:</b> Missed-mine accident	<b>Date of main report:</b> 24/11/2001
<b>ID original source:</b> TKG	<b>Name of source:</b> KMACC
<b>Organisation:</b> Name removed	
<b>Mine/device:</b> PMA-3 AP blast	<b>Ground condition:</b> bushes/scrub rocks/stones route/path woodland (light)
<b>Date record created:</b> 21/02/2004	<b>Date last modified:</b> 21/02/2004
<b>No of victims:</b> 1	<b>No of documents:</b> 1

The accident occurred at Task Dossier Number S20-38, Dangerous Area Number 3826, GR 34T DM 64484 71767 on 16 November 2001 at 1015 hours.

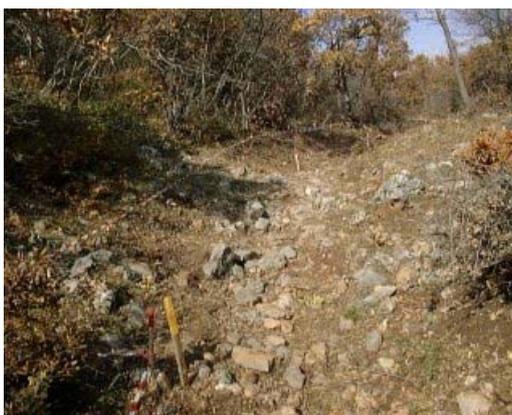
The seat of the explosion was at a distance of 80cm from the centre of the track and plainly inside the cleared area. There are numerous rocks and boulders within this area, and on investigation of the blast hole it was apparent from the indentation in the ground that the rock was approximately 40cm x 40cm. It could not be determined how thick the rock was, as it had been completely destroyed.

[The picture above shows the accident lane.]

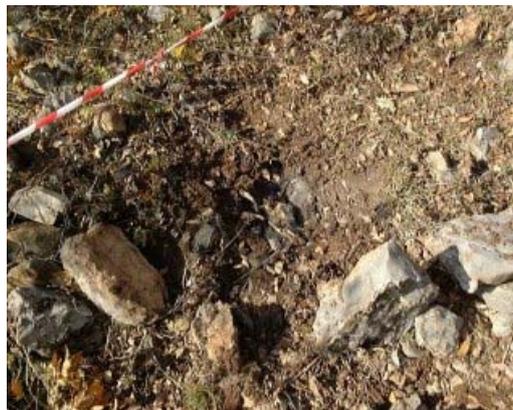
The indentation of the rock that was above the mine could still be seen in the ground during the investigation. The approximate surface area of the rock was 40cm x 40cm. The rock took the bulk of the blast from the mine, which prevented [the Victim] from receiving serious injuries and possible traumatic amputation of his foot.

The investigators did not detail the manner in which they determined the depth of the mine. Other mines found beneath rocks had not been deeply buried. If a large rock was above it, it is likely that the detonation would have disrupted the ground more than it would have otherwise and so the mine may not have been laid as deeply as the investigators supposed. Any PMA-3 laid at that depth would not necessarily detonate when the ground above it was traversed, so there would have been little point in laying the mine so deeply.

The crater at the accident site is shown below.

Removing all rocks is seen as a very inefficient clearance option. The number of mines found under rocks in comparison to the total number of mines located and destroyed does not merit the total removal of all rocks. However there does need to be a compromise to ensure that no further mines are missed and the efficient and effective clearance standard that is required. It is therefore recommended that [Demining group 1] continue with their method of manual clearance, however there is a need to make a more thorough appraisal of rocks that could potentially conceal a mine. These rocks will need to be investigated.

[Demining group 1] are to revisit all their areas cleared in this minefield to date and re-assess rocks that were not moved, in order to investigate potential mines that could be concealed beneath them.
