# DDAS Accident Report

<b>Report date:</b> 19/05/2006	<b>Accident number:</b> 380
<b>Accident time:</b> 12:10	<b>Accident Date:</b> 20/07/2002
<b>Where it occurred:</b> Shama Village, Wadi Jalali ash Sharq	<b>Country:</b> Lebanon
<b>Primary cause:</b> Management/control inadequacy (?)	<b>Secondary cause:</b> Inadequate equipment (?)
<b>Class:</b> Demolition accident (survey)	<b>Date of main report:</b> 09/08/2002
<b>ID original source:</b> BOI:No007/2002	<b>Name of source:</b> MACC SL
<b>Organisation:</b> Name removed	
<b>Mine/device:</b> No.4 Israel AP blast / frag	<b>Ground condition:</b> grass/grazing area rocks/stones
<b>Date record created:</b> 22/02/2004	<b>Date last modified:</b> 17/03/2004
<b>No of victims:</b> 1	<b>No of documents:</b> 3

A summarised MACC BOI report was made available in 2003. It is reproduced below, edited for anonymity. The full Board of Inquiry accident report is in Related papers, under the Other documents tab for this record.

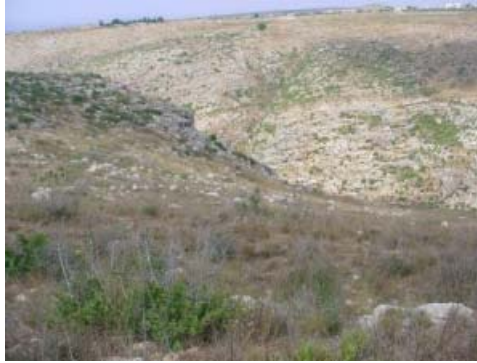
View of the mined area.
