DDAS Accident Report

Report date: 19/05/2006	Accident number: 381
Accident time: 09:38	Accident Date: 26/06/2002
Where it occurred: M/F 178, Bayt Yahun, North of Bint Jubayl	Country: Lebanon
Primary cause: Unavoidable (?)	Secondary cause: Inadequate equipment (?)
Class: Excavation accident	Date of main report: 18/07/2002
ID original source: MF: BOI:No005/2002	Name of source: MACC SL
Organisation: Name removed	
Mine/device: No.4 Israel AP blast / frag	Ground condition: dry/dusty grass/grazing area hard rocks/stones
Date record created: 22/02/2004	Date last modified: 17/03/2004
No of victims: 1	No of documents: 2

REPORT FOR ACCIDENT INVESTIGATION BOARD OF INQUIRY – No005/2002

MINE Accident that occurred in OES 2 on 26th June 2002 in which [Demining group] Deminer [the Victim] was injured.

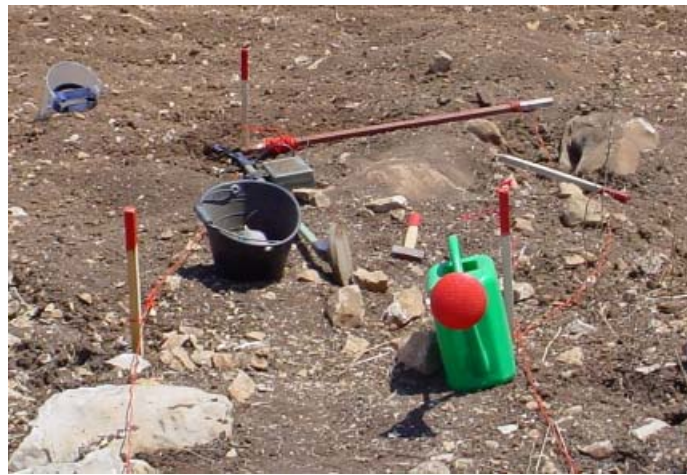
VIEW OF THE ACCIDENT SCENE

- There was a sub-surface detonation of an Israeli No4 Anti Personnel mine. Evidence shows that the crater had heavy blackening to the sides, was of a bulbous shape with primary fragmentation lining the bottom and sides. Lifting had formed on 2 x sides around the seat of detonation (the other 2 x sides having rocks in the way), and detonation blast splash was seen on the right hand rock. The excavated crater size was 25cm x 15cm x 20cm.
