DDAS Accident Report

REPORT FOR ACCIDENT INVESTIGATION BOARD OF INQUIRY

Demining Accident that occurred in MF 324 (NDO 253) on 11 of July 2003 in which [Demining group] DEMINER [The Victim] was injured.

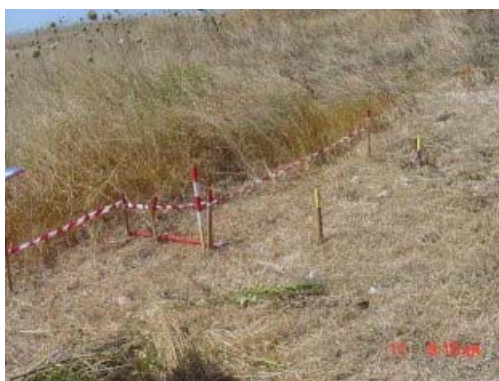
VIEW OF THE ACCIDENT SCENE

There had been an uncontrolled surface detonation of a detonator. Probably it's a Gyata-64 detonator booster.

[The Victim] 's scissor had been in direct contact with the detonator booster at the time of detonation.

The vegetation in the minefield is very thick and this makes the visual inspection more difficult.

[The original report indicated that the detonation occurred in front of the base stick in the "cleared" area.]

The primary cause of this incident is listed as "Unavoidable" because it is not at all clear what the Victim initiated with his vegetation cutting shears. The photographs indicate that the detonation occurred behind the Victim's end-of-lane marking stick. It is not normal to move the stick forward before cutting the undergrowth and clearing the area with a metal-detector or excavation, so the device may have actually been "missed".

- No amendments are necessary to the National TSGs for Mine/UXO Clearance.
- One week of refresher\confidence training with all [Demining group] manual teams working in demining in Lebanon, the training is to include the following:
 - Mine Clearance Techniques i.e. Chapter 4 of TSGs and specially Para. 4.1 thru Para. 4.5.
 - As in this case of thick vegetation and to prevent accidents, the National TSGs allows burning the vegetation (Chapter 4, Para. 4.21), so we recommend using this method if it's suitable to be used (Supervisor decision).
 - Follow the Para. 4.22 Chapter 4 of TSGs which talks about working and break time in special weather and vegetation.
- The conclusion detailed in this report be distributed and discussed among all [Demining group] Operational Field Staff.

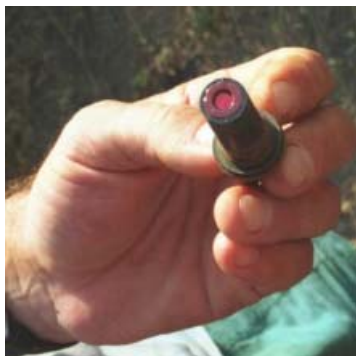
A booster from a GYATA-64 is a small bakelite cylinder with HE inside. At the centre of the HE is a stab-sensitive detonator. This is unlikely to be initiated by touching it, unless the end of the cutting shears probed into the end of the booster. A pin-pull fuze and detonator like that used in the Israeli No.4 AP mine may have been easier to initiate accidentally.

The picture above shows a GYATA-64 booster. The detonator is lacquered red.
