DDAS Accident Report

REPORT FOR ACCIDENT INVESTIGATION BOARD OF INQUIRY – No001/2002

MINE Accident that occurred in OES 3 on 10 May 2002 in which [Demining group] Team Leader [name excised] was injured.

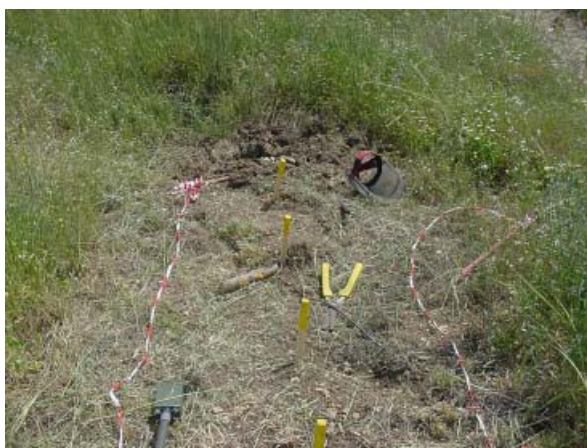
VIEW OF THE ACCIDENT SCENE FROM THE CLEARANCE LANE.

The Victim’s visor is to the right of the seat of detonation.
