DDAS Accident Report

REPORT FOR ACCIDENT INVESTIGATION BOARD OF INQUIRY – No011/2002

DEMING Accident that occurred in OES 2 on 21st October 2002 in which [Demining group] Deminer [the Victim] was injured.

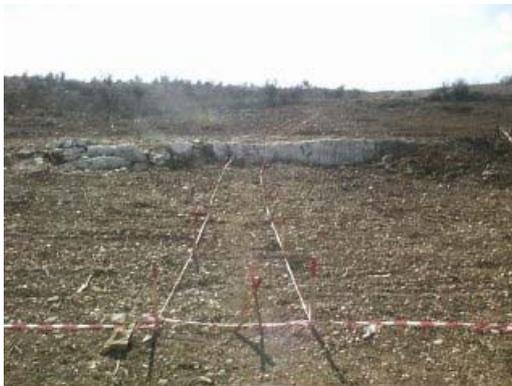
Minefield 358A [is shown below]. Showing the second access lane, previous flailed area and accident marking.

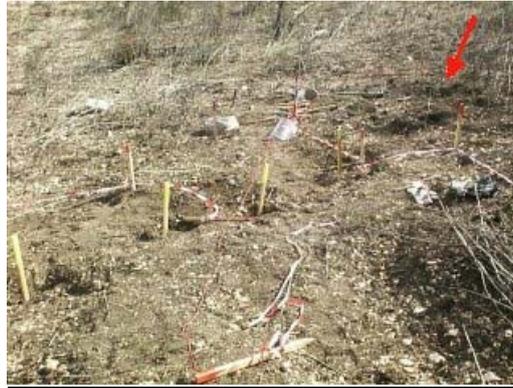
VIEW OF THE ACCIDENT SCENE FROM THE BASE LANE

[The accident scene following the accident. Marking is at best “confusing”. The seat of initiation is marked with a red arrow. Several other pictures of the site add little value and their overlay of explanatory lines became confused in file transfer, so they are omitted.]

- A. The uncontrolled detonation occurred when the Deminer marked a lane by knocking a red marking picket on top of the mine.
- B. There was a sub-surface detonation of an Israeli No4 enhanced Fragmentation Anti Personnel mine. The excavated craters radius was 90 cm and the depth 26 cm.
- C. At the time of the uncontrolled detonation, the mine would have been directly below the location of the marking picket; the deformation of the marking picket and [the victim]'s injuries substantiates this.

- A. The Clearance Team is suspended for a period of 7 x working days for refresher training.
- B. Marking picket should only be inserted in areas that have been previously cleared.

- C. All demining lanes should be marked in accordance with current SOPs by the deminer who clears that lane.
- D. Team Leaders are not to clear mines but to concentrate on leading and supervising team deminers.

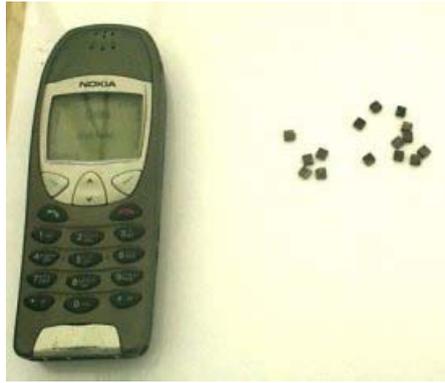
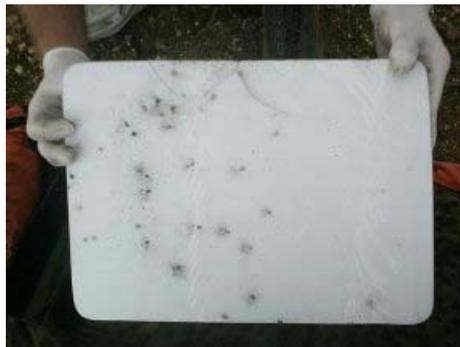
[The victim's] PROTECTIVE JACKET

33. At the time of the accident, [the victim] was wearing his protective apron and protective visor. On inspection of the protective apron, the following points were noted:

- The outer cover was ripped in several places.
- The blast debris and damage was concentrated on the left hand side.
- The polycarbonate chest plate was fractured in various places

[The apron worn by the victim has a cotton cover (for comfort) and this is usually damaged in any accident. The ballistic aramid inner is not Kevlar. To raise the protection offered in “vital areas” the apron has a small, optional polycarbonate insert in the chest area. In this case the insert was in place. It is shown below along with some of the 3mm square fragments of steel recovered from inside the armour. No fragments fully penetrated the armour or the visor.]

- P. The protective jacket maintained its integrity following the uncontrolled detonation of an Israeli No4 enhanced Fragmentation AP mine.
- Q. The protective visor maintained its integrity following the uncontrolled detonation of an Israeli No4 enhanced Fragmentation AP mine.

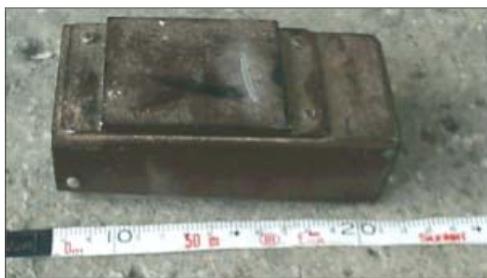
ISRAELI NO4 AP BLAST [and frag] MINE

40. The No 4 mine found in Mine Field 358 A is modified with a pre-cut fragmented metal plate that measures 7 cm x 6 cm x 4 mm. There is no information from IF why these particular No 4 Mines were enhanced with a metal plate. Upon detonation the metal plate fragments into small shrapnel approx 3 mm x 3 mm. All mines previously located in Mine field 358 A were of this model.

[This No.4 has a metal plate screwed to the lid – and behind the plate is a matrix of pre-cut fragments that turn the blast mine into a fragmentation mine.]

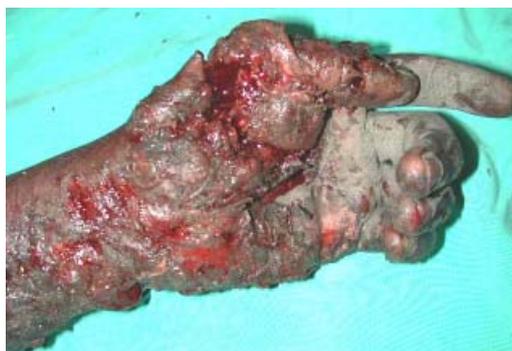
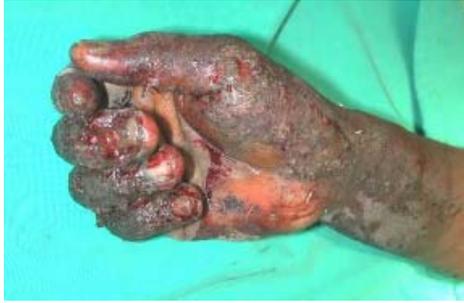
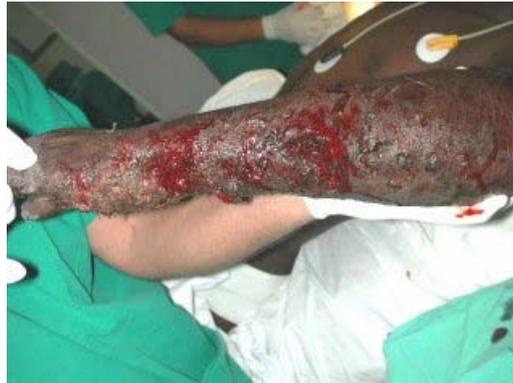
Pictures of the victim's injuries allow some further assessment to be made.
