DDAS Accident Report

| Where it occurred: MF: 466, Jabal Balat | Country: Lebanon |

REPORT FOR ACCIDENT INVESTIGATION BOARD OF INQUIRY – No009/2002

DEMING Accident that occurred in OES 1 on 21st September 2002 in which [Demining group] Deminer [name excised] was injured.

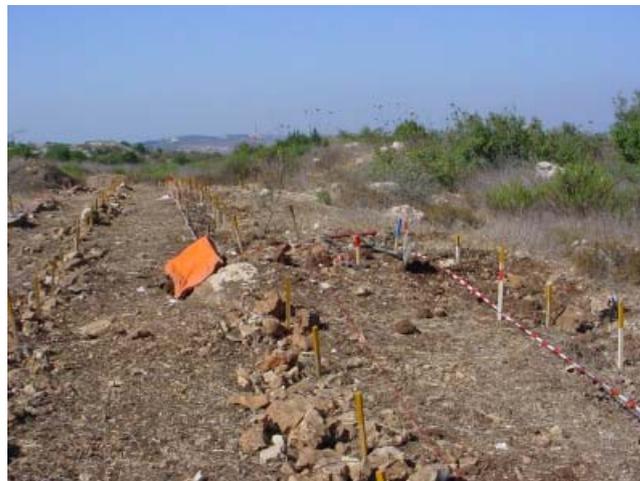
VIEWS OF THE ACCIDENT SCENE

Lane "C" M/F 466 is the one on the right in the picture above.

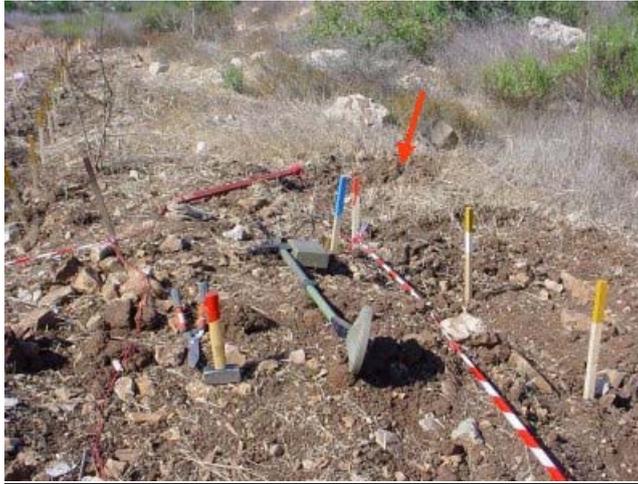
[The seat of initiation is shown by the red arrow in the picture above. Note inadequate marking.]

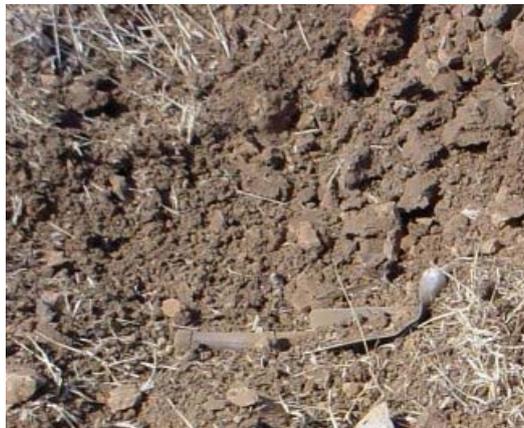
[The picture above shows the crater and the damaged trowel.]

- E. There was a sub-surface detonation of the mine, evidence shows that the crater had heavy blackening to the sides, was of a bulbous shape and contained primary fragmentation.

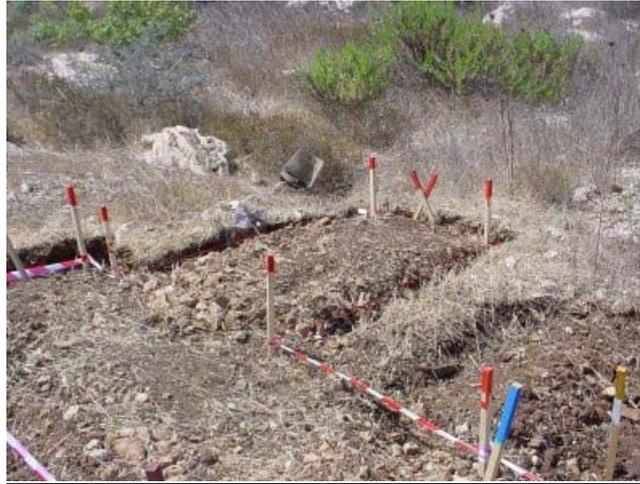
VIEW SHOWING THE SECOND BOI REQUESTED CLEARED AREA

[The picture above shows how the area looked after it had been cleared and marked for the Bol team. The clarity of the marking contrasts greatly with the pictures taken immediately after the accident. The visor is in both, so helping to identify what has been done.]

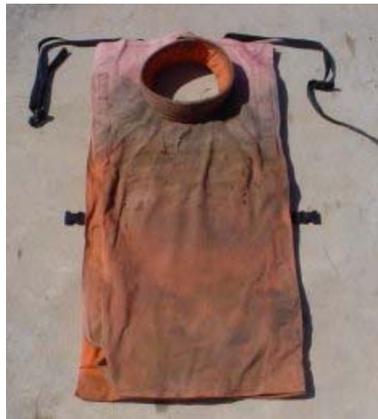
VIEW SHOWING DEMINER'S PROTECTIVE JACKET

27. At the time of the accident, [the Victim] was wearing his protective apron and protective visor. On inspection of the protective apron, the following points were noted:

- The outer cover had been torn in several places by secondary fragmentation.
- The inner polycarbonate plate pocket material had been torn by secondary fragmentation.
- The inner polycarbonate plate had spoil deposits on it (secondary fragmentation disintegration).
- The blast debris and damage was concentrated in the centre of the jacket.
- There was fragmentation penetration of the Kevlar lining.

[The apron's cotton cover was torn. The polycarbonate chest insert was marked by disintegrated fragments (dust) but not damaged.]

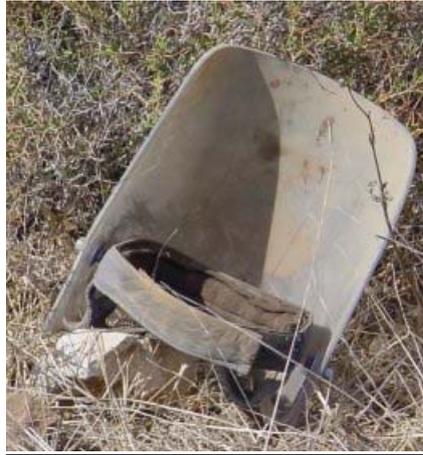
VIEW SHOWING PROTECTIVE VISOR

28. On inspection of parts of the protective visor, the following points were noted:

- The visor face had maintained its integrity.
- There was secondary fragmentation damage to the centre of the visor face, but no fragmentation penetration.
- The visor securing bolts had maintained their integrity.

- O. The protective visor maintained its integrity following the uncontrolled detonation of an Israeli No4 AP mine.
- P. The use of a demining probe to investigate signals, in conjunction with a more lightweight demining trowel may reduce the risk of any uncontrolled detonations occurring. When used correctly, Deminers have a tangible and physical indication of any hidden object prior to any excavation actually being undertaken.
- Q. Deminers adopting the prone position when investigating signals will minimise the injuries sustained, should an uncontrolled detonation occur.
- R. Paragraph 4.19 to Chapter 4 of National TSGs does not cover in sufficient details the action to be taken when clearing around rocks.

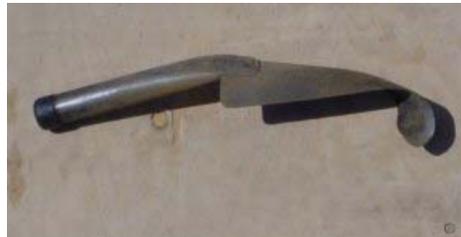
VIEW SHOWING EXCAVATION TROWEL

30. On inspection of the trowel, the following points were noted:

- The trowel tip (last third of the blade), had been deformed quite considerably.
- There was a small crease on the underside of the trowel, 13cm from the blade / handle joint.
- There was heavy blackening confined to the second third of the trowel blade, around the location of the small crease as detailed above.

[This trowel is made in Zimbabwe and featured in several accidents there. In two cases, it caused severe injury to the user, in one case the injuries resulted in death. The inadequacy of the trowel has been observed before.]

- C. The mine functioned when the bottom side of the demining trowel pushed down on the plastic lid of the mine. This in turn would have released the slotted striker retaining plate and subsequently released the cocked striker mechanism. Evidence to substantiate this conclusion are detailed below:

- The small crease on the underside of the trowel, 13cm from the blade / handle joint was part of the trowel that was in intimate contact with the mine lid when the mine detonated. The crease formed on the detonation of the high explosive fill.

- The trowel tip had deformed quite considerably because this is the weakest part of the trowel and the part of the trowel that would have been closest to the mine main explosive fill when it detonated.

- The heavy blackening confined to the second third of the trowel blade (around the location of the small crease), is a residual effect of detonating high explosives.

- a. [Demining group] should introduce a probe and a lightweight excavation trowel procedure into their current SOPs. The International Deminers currently working for [Demining group] should have access to the full range of manual clearance tools and equipments that are available.
