DDAS Accident Report

Report date: 17/03/2004	Accident number: 394
Accident time: 15:55	Accident Date: 13/05/2002
Where it occurred: MF: 501, Arid al Mazra'ah, Nr Bra'Shit	Country: Lebanon
Primary cause: Inadequate training (?)	Secondary cause: Inadequate equipment (?)
Class: Handling accident	Date of main report: 23/05/2002
ID original source: Bol: 002/2002 MJF	Name of source: MACC SL
Organisation: Name removed	
Mine/device: Fuze	Ground condition: not applicable
Date record created: 27/02/2004	Date last modified: 27/02/2004
No of victims: 1	No of documents: 1

REPORT FOR ACCIDENT INVESTIGATION BOARD OF INQUIRY – No002/2002
MINE Accident that occurred in OES 3 on 13th May 2002 in which [Demining group] Deminer [the Victim] was injured.
Map Reference: UNIFIL Genimap 1:50,000 Sheet A (Tibnin).
References: A. Janes Mines Manual.

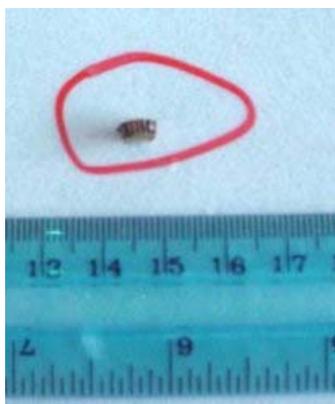
20. [The victim] suffered deep fragmentation lacerations to the insides and tip of his left hand middle, ring and index fingers, a minor closed fracture of his left hand middle two fingers and a deep laceration on the inside of his left hand thumb. There was also a small minor fragmentation laceration to [his] right hand palm. [Demining group] Survey Team Medic administered medical treatment and stabilisation on-site to [the victim] (wound dressings and intravenous "Ringer" solution); casualty evacuation by road to Bint Jubayl civilian hospital then took place.

FRAGMENTATION RECOVERED FROM LEFT HAND THUMB

The photograph of a fragment removed from his hand is further evidence that the injuries were serious.
