DDAS Accident Report

Report date: 15/03/2004	Accident number: 395
Accident time: 14:30	Accident Date: 26/09/2002
Where it occurred: Raab ett Talatine	Country: Lebanon
Primary cause: Inadequate survey (?)	Secondary cause: Management/control inadequacy (?)
Class: Missed-mine accident	Date of main report: 21/10/2002
ID original source: Bol: 010/2002: MJF	Name of source: MACC SL
Organisation: Name removed	
Mine/device: TM46 AT blast	Ground condition: agricultural (recent) rocks/stones
Date record created: 27/02/2004	Date last modified: 27/02/2004
No of victims: 1	No of documents: 1

REPORT FOR ACCIDENT INVESTIGATION BOARD OF INQUIRY – No010/2002
MINE Accident that occurred in OES 3 on 26th September 2002.
Map Reference: UNIFIL Genimap 1:50,000 Sheet A (Tibnin).

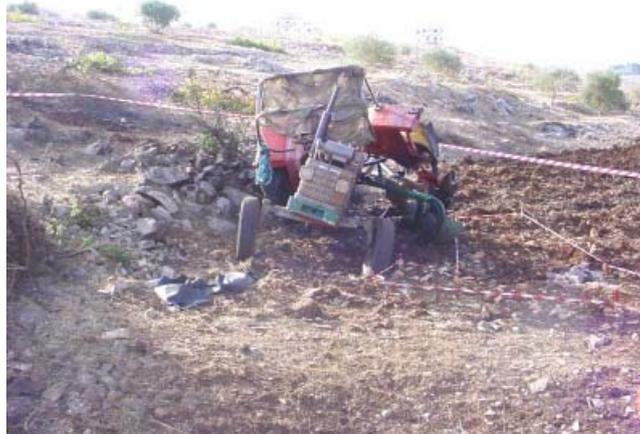
PHOTOGRAPH SHOWING THE ACCIDENT AREA

4. On the 26th September 2002 at approximately 1430 hrs whilst [Name excised, the Victim], was ploughing a field in Raab ett Talatine, a detonation occurred under the left hand back wheel of his tractor. [The victim] managed to extract himself from the tractor and make his way to the side of the field whereupon he was assisted by the landowner, [name excised] and taken to Marjayoun Hospital.
5. The details of the accident were passed to [name excised] the Mukhtar (village head), of Raab ett Talatine who passed them directly to the Community Liaison Officer (CLO) Team Leader [name excised]. [The CLO] then passed all details to MACC SL Operations Officer who subsequently tasked MACC SL QA Officer to conduct a Mine Accident Investigation.

- g. The tractor was lifted and moved approximately 2m to the North East following the uncontrolled detonation.
 - h. The Mine Accident AT crater was located inside a previously cleared [Demining group] MDD area that had been physically marked and included in the Completion Report.

- a. The area that was cleared by MDD assets in M/F 299 be re-cleared using Manual assets and the completion report amended accordingly.
- b. Completion Report information must be a true and accurate reflection of the clearance activities that have been conducted. All cleared areas must be marked, mapped and recorded accurately both physically on the ground and annotated in Completion Reports.

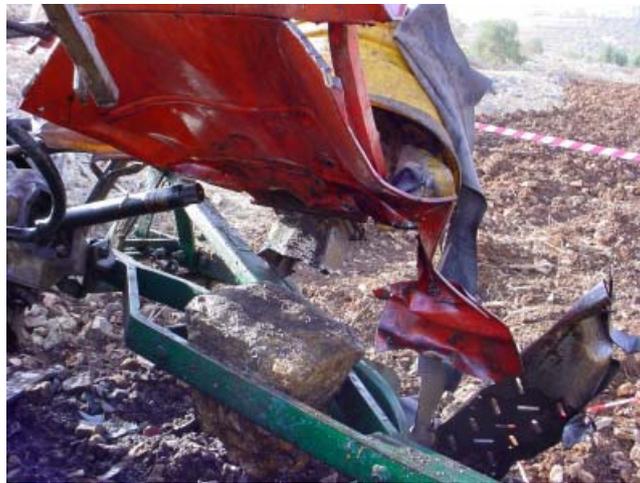
[Photograph showing the damage to the tractor wheel (the wheel hub was yellow).]

- e. The detonation occurred when the tractor driven by [the victim]. Drove over the location of the said TM-46 AT mine, with the detonation occurring directly under the tractor's back left hand wheel.

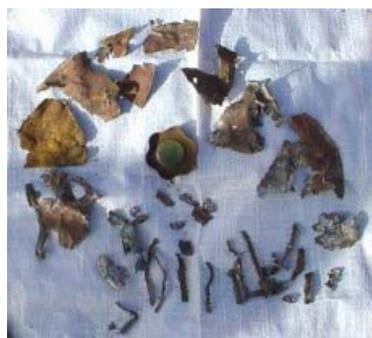
PHOTOGRAPH SHOWING RECOVERED MINE FRAGMENTS

8. At 0630 hrs on the 27th September 2002, [Demining group] EOD Team commenced clearance to the seat and around the seat of detonation and at 0745 hrs clearance was completed. Once the clearance had been completed, the BOI excavated the crater and primary fragment remnants of a TM-46 Anti Tank (AT) mine were recovered. No actual explosive items were located by the EOD Team or the BOI during the clearance.

19. Based on the Accident Investigation the following is concluded:
- a. There was a sub-surface detonation of a TM-46 (fuzed MV-5), AT mine.
 - b. The crater measured 48cm deep and 70cm wide, with large quantities of TM-46 primary fragmentation lining the sides and bottom the crater. 50% of the crater showed signs of a bulbous effect (heavy soil area), no bulbous effects was shown in the other 50% of the crater due to rocky ground.

- c. Based on the above conclusion, it is estimated that the TM-46 AT mine detonated at a depth of 300mm / 350 mm below the surface.
 - d. The TM-46 AT mine may have been originally laid by Palestinian forces and not Israeli forces.

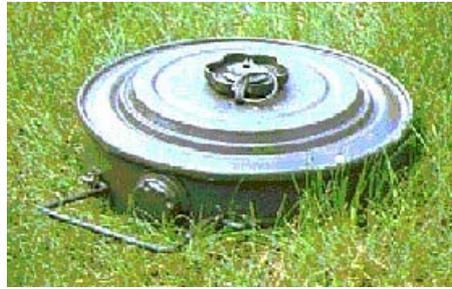
PICTURE SHOWING TM-46 AT MINE WITH MVM FUZE FITTED

16. The TM-46 Anti Tank (AT), mine is a large metal cased AT blast mine of Soviet origin containing 5.7kgs of TNT. The cylindrical body has a stepped pressure plate with a central

threaded fuze well. On the side of the mine a steel carrying handle and a filler plug are located, on the base of the mine there are 5 x stamped reinforcing ribs.

17. In addition to the standard pressure fuzes (MV-5 and MVM), the mine can also accept a tilt-rod fuze (MVSh-46), that gives it a full width attack capability against vehicles.
