DDAS Accident Report

REPORT FOR ACCIDENT INVESTIGATION BOARD OF INQUIRY – No 003/2003

DEMINGING Accident that occurred in OES 5 on 8th August 2003 in which [Demining group] Deminer [name excised] was injured.

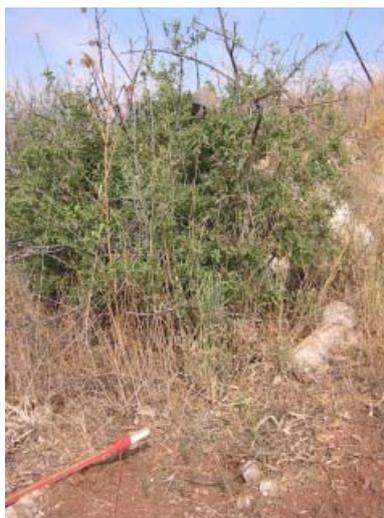
LOCATION OF VISOR

[The visor is in the top of the bush shown here.]

27. The visor was discovered lodged in top of the bush 2-3m from the seat of detonation. On inspection the following were noted:

- The vast majority of blast and fragmentation that hit the visor were absorbed by it.
- There is a 2mm hole slightly left of centre mid way up the visor.
- The polycarbonate has cracked around the left hand visor pivot point.
- Small pieces of hot fragmentation have melted the polycarbonate and have embedded into the outer face.

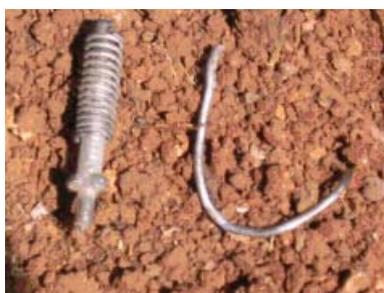
VIEW SHOWING REMAINS OF MUV FUZE STRIKER AND SAFETY PIN RING

- The crater had formed through a sub-surface detonation of an Israeli No4 mine.
- A striker from an MUV type fuze was located along with the safety pin ring.
- Israeli No4 mine primary plastic fragmentation was located.

- e. [Demining group] are to disseminate to all demining personnel the danger of accumulated pressure on the MUV fuze as fitted to the No 4 AP mine. Prior to the accident there was a train of thought that this fuze could be difficult to activate due to corrosion and [Demining group] introduced a neutralization method for use where necessary. The accident itself and **unreported** sympathetic detonations on SHA 18 indicate that fuze can be as sensitive as a No 9 igniter.

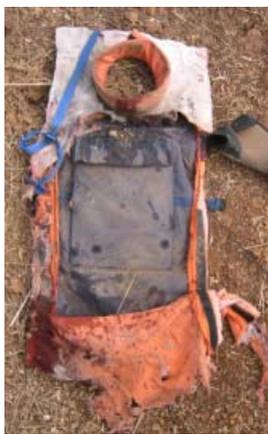
VIEW OF [Victim]'S PROTECTIVE VEST

- The outer cover was ripped from the top downwards
- The blast debris was concentrated in the upper third slightly right of centre
- There was part fragmentation penetration of the Kevlar lining.
- Neck guard was intact
- The breast plate was broken diagonally however there was no fragmentation penetration into the vest behind it.

[The torn cotton outer has been peeled back to reveal the ballistic aramid (NOT Kevlar) inner with a pocket containing a sheet of 5mm polycarbonate to raise the protection level over the chest. The polycarbonate insert had snapped in half.]

- e. He was correctly wearing his full complement of PPE as per [Demining group]'s SOP. (Safety goggle frames were uncovered in the uncleared area on 14/08/03) The good quality of the PPE has undoubtedly saved [the Victim] from very serious injury. The protective jacket maintained its integrity.

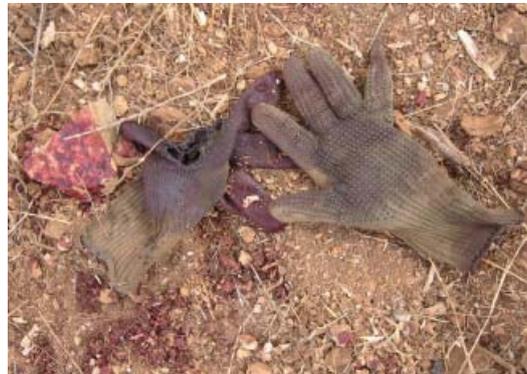
- The left hand glove did not suffer any damage
- The right hand glove has been generally retained its integrity against the blast and fragmentation. However it was cut severely in the area between the base of the thumb and the forefinger where the excavation tool was gripped.

[The gloves are shown above.]

- f. Visor was breeched on the left side but maintained sufficient integrity as to ensure that no serious facial injuries were sustained to him.
- g. The Kevlar gloves kept their integrity against the mine blast. However the tear/cut in the fabric between the base of the thumb and forefinger and the resulting deep laceration was caused by the blast wave forcing the shoulder of the excavation tool into the hand.

- c. Leather gauntlets should not to be worn on top of protective working gloves when conducting excavation and prodding drills. [Demining group] are to state in the company SOPs the criteria for wearing leather gauntlets.
