DDAS Accident Report

REPORT FOR ACCIDENT INVESTIGATION BOARD OF INQUIRY – No 009/2001

Mine Accident that occurred in MNB West on Friday 20 July 2001 in which [Demining group] Section Leader [The Victim] was injured.

4. The accident occurred at one of the Rasa Koshare minefield's, Task Dossier Number W02-37, minefield number 305, GR 34T DN 3450 0255 on 20 July 2001 at 1125 hours.

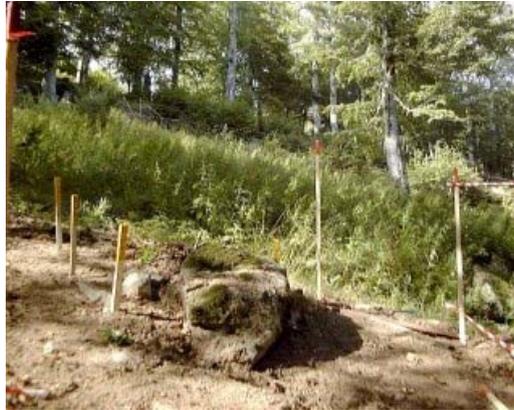
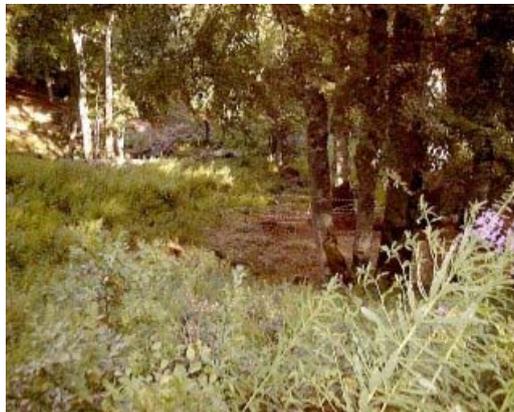
VIEWS OF ACCIDENT SITE

6. On the morning of the accident a pile of mines were discovered at the base of a large tree approximately 7 metres before the seat of the explosion, this pile consisted of 8 x PMR2A, 1 x PMA1 and 1 x PMA2. [The Victim] had disarmed these mines and they were removed. The clearance lane then continued. In this lane there is a large rock, and beside this rock a PMR2A was discovered as well as 3 x PMA2. These mines were all disarmed and removed. The deminer was continuing with the clearance of this lane when [the Victim] came into the lane and was in the process of erecting mine marking tape when she stepped on what is believed to be a PMA2 blast mine. As a result of the explosion her right foot was traumatically amputated, and she was thrown to the ground. The force of the explosion was such that it blew her foot 30m up the hill and onto the road, along with her right boot. The deminer that was working in this lane was 2m from the blast, and he received a superficial injury to his shoulder. Immediately after the blast [the Victim] was carried from the lane up to the road where she was given first aid treatment and stabilised. From here she was taken by ambulance to await the arrival of the CASEVAC helicopter at HLS – Red 26, 2km down the hill.

- All blast mines located in this minefield (over 100 to date) have been within the excavated depth of 5 cm.
 - This mine was not located during the excavation drill as it was at a depth of 16cm.

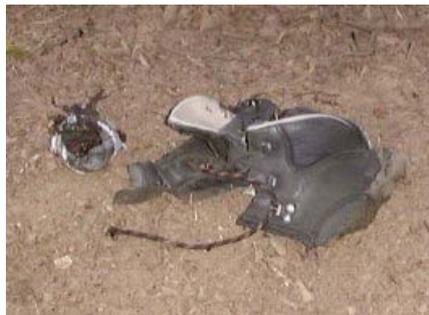
VICTIM'S RIGHT BOOT

- Traumatic amputation of right foot with concomitant destruction of surrounding tissues.
- Burn wound on the lower part of right arm.
