DDAS Accident Report

Report date: 10/03/2004	Accident number: 403
Accident time: 09:12	Accident Date: 05/03/2001
Where it occurred: Veli village, municipality Berkovii, Nr Stolac	Country: Bosnia Herzegovina
Primary cause: Field control inadequacy (?)	Secondary cause: Management/control inadequacy (?)
Class: Missed-mine accident	Date of main report: 09/03/2002
ID original source: VMM, RB	Name of source: RS MAC BiH
Organisation: Name removed	
Mine/device: PROM-1 AP Bfrag	Ground condition: rocks/stones grass/grazing area
Date record created: 06/03/2004	Date last modified: 09/03/2004
No of victims: 1	No of documents: 1

BOARD OF INQUIRY REPORT - DEMINING ACCIDENT MARCH 5th 2001 March 9th 2001.

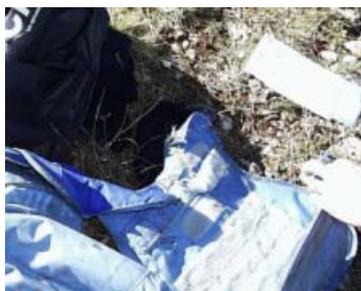
34. The protective jacket shows transparent holes at the upper chest part as well as at the left neck protection part. Crotch protection also contains visible shrapnel holes. (Photographs shown in Annex C).

[The picture shows some damage to the neck of the Victim's armour apron.]

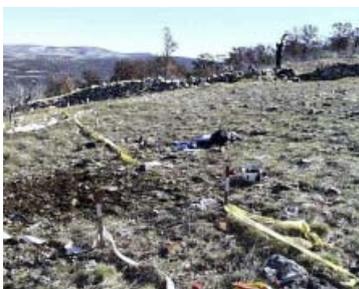
37. The injured deminer stepped on a PROM-1P mine at about 3.60m from the beginning of his lane, which indicates that he had 'cleared' about 4 square metres since he started to work.

[The picture shows the accident site. Photographs showing the victim's boot and what appear to be bits of the victim's leg were also made available.]

45. Mine was activated by pressing the left foot on the PROM-1P mine fuse. The mine activated just above the ground level. The position of the leg torn by the explosion indicates that the mine exploded right behind the left leg (left boot damaged). The body was in the position for flushing the pickets into the ground (left hand holding the picket – 2nd and 3rd finger of the left hand amputated, while the hammer was in his right hand), which is indicated by the reports of both the medic and the doctor at the emergency hospital in Trebinje. In the moment of explosion, the base stick was placed in front of the deminer (in front of the mine that exploded – while the mine remained in the cleared area) at probably at the left leg boot. The location of where the base stick parts were found as well as the leg torn by the explosion stands for this fact.

58. It is necessary to re-train the team regarding the basic procedure in the working lane, especially at area similar to the one where this task was conducted.
