DDAS Accident Report

Report date: 06/07/2005	Accident number: 412
Accident time: 08:55	Accident Date: 08/06/2004
Where it occurred: Vanankerny Village, Kilinochi District	Country: Sri Lanka
Primary cause: Unavoidable (?)	Secondary cause: Victim inattention (?)
Class: Excavation accident	Date of main report: 09/06/2004
ID original source: [Name removed]	Name of source: [Name removed]
Organisation: [Name removed]	
Mine/device: P4Mk2 P4Mk1 AP blast	Ground condition: grass/grazing area soft
Date record created: 06/07/2005	Date last modified: 06/07/2005
No of victims: 1	No of documents: 2

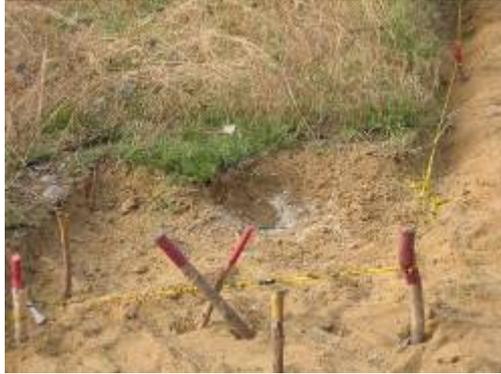
The picture below shows the accident site and the blast crater.

“The deminer was working in his clearance lane using a heavy rake to excavate the ground. The ground was very hard and use of the light rake was limited. At approximately 08:55hrs an explosion occurred under the rake.”

I believe and confirm the deminer activated the mine. He applied the heavy rake with pressure over 3.5kg pressure. I had a deep look on the ground. According the land type the grass had heavy long root and he used heavy rake to take off it. I instructed Northern Ops officer [name excised] train this team on how to use the tools according to the grass type for half a day. I warned the deminer that this happened by careless heavy rake use. I recommend that we immediately suspend the deminer and discipline him.
