DDAS Accident Report

Report date: 06/07/2005	Accident number: 413
Accident time: 10:15	Accident Date: 27/06/2004
Where it occurred: Puliyankulam village, Vavuniya District, Vanni	Country: Sri Lanka
Primary cause: Inadequate equipment (?)	Secondary cause: Field control inadequacy (?)
Class: Other	Date of main report: 28/06/2004
ID original source: KS	Name of source: LA
Organisation: Name removed	
Mine/device: P4Mk1 AP blast boosted	Ground condition: grass/grazing area hard
Date record created: 06/07/2005	Date last modified: 06/07/2005
No of victims: 0	No of documents: 2

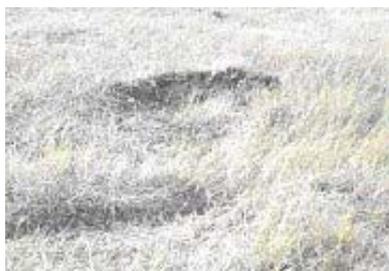
The tyre of the tanker was damaged when it ran over a PK-Mk4 AP mine “attached to a 60mm mortar”.

[The blast crater left by the device is shown above.]

The primary cause of this accident is listed as *“Inadequate equipment”* because the water bowser used was too big to be safely manoeuvred inside the mined area. It had been unable to turn without using the uncleared area on a previous occasion and the driver had been instructed to use the uncleared area. The instruction to use an uncleared area for vehicle turning is the reason that the secondary cause of the accident is listed as a *“Field control inadequacy”*. The field supervisors could have ordered areas close to the bund to be cleared so that the vehicle could manoeuvre on cleared land, but did not do so.

The demining group involved developed a Safe-lane water bowser capable of moving inside 2 metre wide lanes and reversing along them during 2005.
