DDAS Accident Report

Report date: 08/07/2005	Accident number: 416
Accident time: 10:32	Accident Date: 09/09/2004
Where it occurred: Punnalaikadduwan village, Valikamam South, Jaffna Province	Country: Sri Lanka
Primary cause: Unavoidable (?)	Secondary cause: Unavoidable (?)
Class: Excavation accident	Date of main report: 10/09/2004
ID original source: JA-132 / LK-225 SP	Name of source: SP
Organisation: Name removed	
Mine/device: P4Mk2 P4Mk1 AP blast	Ground condition: bushes/scrub hard hidden root mat
Date record created: 08/07/2005	Date last modified: 08/07/2005
No of victims: 1	No of documents: 1

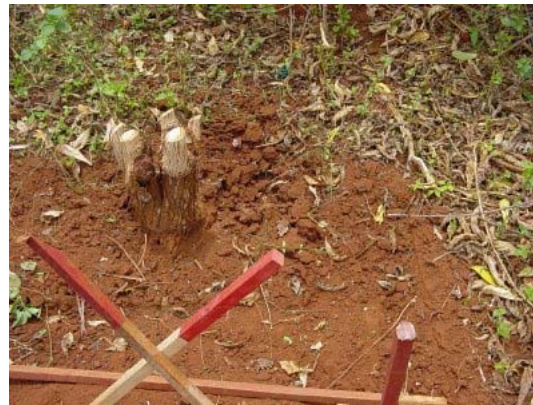
“Incident spot terrain is hard, red clay type soil with vegetation. Soil is softened before raking by moisturizing it with plenty of water. Antipersonnel mine was situated in a clear clay spot without rocks and partly surrounded by approximately 5 year old tree. There were not disturbing objects around.

[The picture above shows the accident site with the small crater alongside the stumps of a small tree.]

“Shape of the explosion crater is small 30 cm x 30 cm x 15 cm and perfectly round shaped, which slightly leads to a conclusion that P4 was laid in normal horizontal (pressure plate upwards) position. It is possible, that P4 was damaged and missing parts of its pressure plate and therefore more sensitive.”

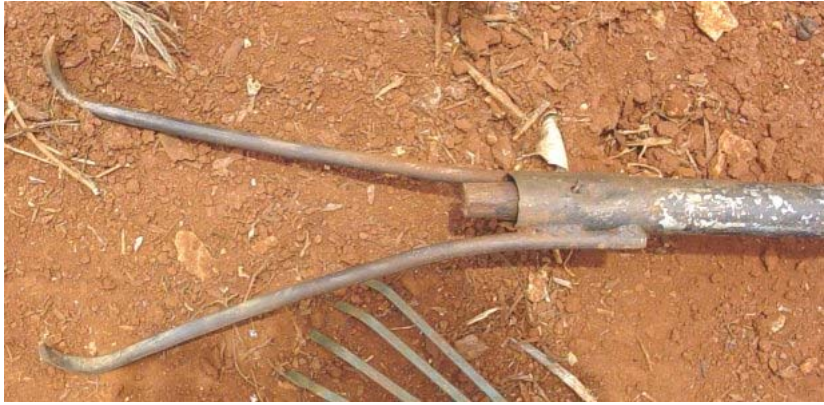
[The picture of the damaged rake shown above is of an SOP approved 2-tine rake. The tines appear worn so that they do not “hook” as shown in the group’s SOPs, but this may have been caused by the blast. The tines have been splayed by the blast.]

The primary and secondary cause of this accident are listed as “*Unavoidable*” because it seems likely that the deminer was working as directed to approved SOPs when the initiation occurred. It is possible that the rake tines were worn and misshapen, but this may have occurred in the blast.
