DDAS Accident Report

Report date: 01/08/2006	Accident number: 423
Accident time: 09:35	Accident Date: 19/04/2006
Where it occurred: TMAC Task TSIS529, Nr Halkayor Village, Panj district, Khatlon Region	Country: Tajikistan
Primary cause: Management/control inadequacy (?)	Secondary cause: Inadequate training (?)
Class: Other	Date of main report: 26/04/2006
ID original source: [Name removed]	Name of source: [Name removed]
Organisation: [Name removed]	
Mine/device: PMN AP blast & booby trap	Ground condition: grass/grazing area metal fragments rocks/stones
Date record created: 24/07/2006	Date last modified: 01/08/2006
No of victims: 2	No of documents: 3

Tajikistan Mine Action Centre, REPORT OF BOARD OF INQUIRY INTO DEMINING ACCIDENT ON 19 APRIL 2006

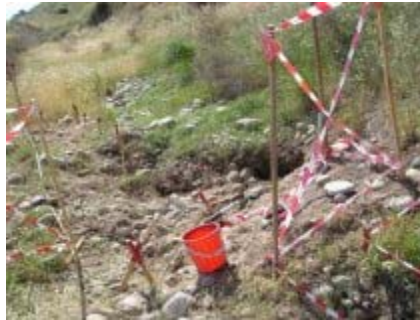
13. The accident occurred near the village of Halkayor, in Panj district, Khatlon Region. Lat/Lon 37° 10' 00" N, 69° 15' 00" E. Elevation is 370 metres. Map sheet J-42-103-Г (10-42-103-4). See map at Annex D.
14. The general area where the accident occurred is rough country, in a region adjacent to agricultural fields, meadow and pastureland. The area is covered with grass, small trees and bushes.
15. The minefield is situated at the base of a line of steep-sided hills and the clearance lane where the accident occurred is on stony ground, at the base of an earth cliff, on the northern bank of the Panj River.

[The picture below shows the accident site.]

17. An unsurfaced track and an irrigation channel run parallel and next to each other, through the area. The track terminates next to a sluice gate in a dam, which may be used as a footbridge to access the minefield, situated next to the irrigation channel. The nearest tarmac road is approximately 21 Kilometres away, at the town of Panj. The point where the mine detonated was approximately 50 metres from the unsurfaced track, to the north, or left-hand side of the track.

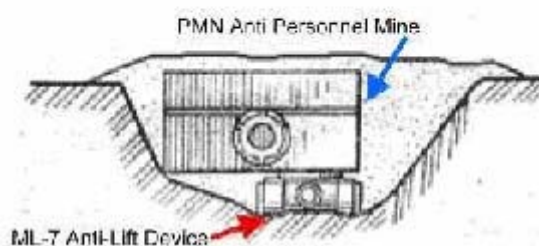
54. Fragments recovered from the crater created by the blast of the explosion show that the mine involved was a Russian PMN anti-personnel blast mine, coupled together with a ML-7 booby-trap switch. Crater left by the detonation is as would be expected from expected from such a device.
55. A PMN anti-personnel mine is loaded with 249 grams of high explosive. It is designed to be operated by 8 to 25Kg of pressure from above.

56. An ML-7 booby-trap switch is loaded with 40 grams of high explosive. It is designed to be operated by the removal of 4Kg pressure.

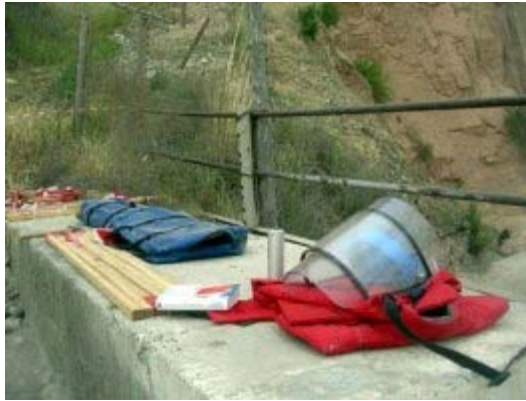
60. All members of the team involved were issued with their own set of personal protective equipment, consisting of a blast resistant apron/jacket and a blast-resistant visor. When [Victim No.2] was evacuated from the clearance lane, he was still wearing his blast-resistant jacket. His visor sustained some slight damage as it was blown from his face; it was recovered from a point approximately three metres outside the cleared lane during the Board of Inquiry inspection of the accident site.
61. [Victim No.1] was not wearing PPE when he was evacuated from the clearance lane. The Board of Inquiry noted that a full set of PPE was located, with the jacket folded neatly and the visor placed on top of it, on the bridge approximately ten metres from the point of detonation of the mine involved in this accident [as shown below].

62. Each member of the team was also wearing a pair of 100% cotton trousers and a 100% cotton jacket, issued by [Demining Group]. Leather working gloves are also issued and [Victim No.2] was wearing these at the time of the accident.
63. At the time of the explosion, [Victim No.1] was wearing lightweight hiking boots, as shown in the image at Annex M. The right boot was severely and extensively damaged; the sole was cut and a large part of the boot's upper was ripped and frayed from the effects of the explosion as it was blasted away from his foot. The other boot has not so far been found and it is most likely that this was completely annihilated during the detonation which destroyed the lower part of [Victim No.1]'s left leg.
64. No other protective equipment was worn or issued to the personnel involved.

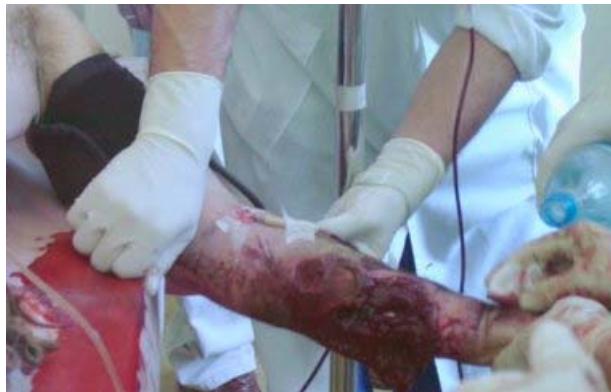
Photographs showed severe damage to hands and forearms (the left forearm is shown below). There was also severe damage to the right side of the face.

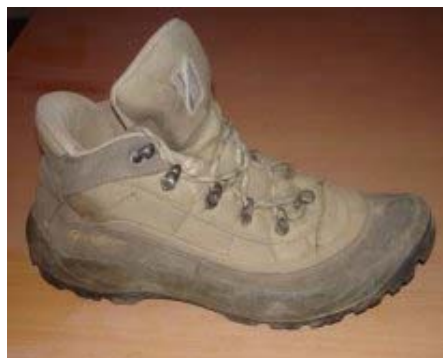
The Victim's boot was later found (three months later) in perfect condition 18m metres from the seat of initiation (it may have been moved by animals). There was no sign of the missing foot, blast damage or blood.

The picture above shows the boot.

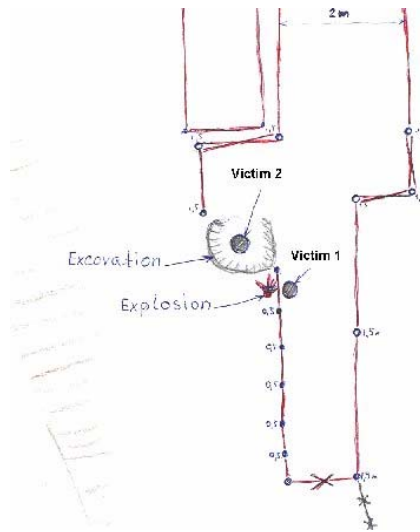
The incident occurred 23cm outside the cleared area, but a sketch map in Annex H showed Victim No'1's position was just inside the cleared area.

If the drawing were to scale he would have been 40cm from the blast. Statements (held on file) report that he had shown scant regard for perimeter markings before, so it seems likely that he stepped over the tape in order to supervise Victim No.2 and initiated the device by stepping directly onto it. According to witnesses, the victim “regularly sat on the ground to watch deminers while they were working. He usually sat at a distance of 1 to 2 metres from the working deminer”. From the injuries, it is likely that his first foot would have stepped alongside the device, and his second on top of it – so explaining how the initiation could cause severe injury to both legs, destroying one shoe and severely damaging the other. He may then have fallen backwards landing inside the cleared area as shown on the sketch.

The primary cause of the accident is listed as a *Management control inadequacy* because the senior expatriate on site was in regular breach of basic safety rules which finally led him to suffer a fatal injury. This man represented the “international management” and had to be present before any work could be conducted. Despite the responsibility vested in him, he regularly failed to obey the demining group’s IMAS compatible SOPs. The secondary cause is listed as *Inadequate training* because Victim No.1’s risk taking implies that either he had never been adequately trained so that good practice became habitual, or he was in need of refresher training. His risk taking was the direct cause of the injuries suffered by the second victim.

87. All personnel at all work sites should conform to all aspects of [Demining Group]'s Standing Operational Procedures. Specifically, this should mean that, when they are working within hazardous areas, personnel deployed on mine clearance operations should not walk outside known cleared areas.
