DDAS Accident Report

Report date: 31/07/2006	Accident number: 424
Accident time: 09:30	Accident Date: 05/08/2004
Where it occurred: DMAO Task No 35/03, VA-20. Vankalai, Mannar District	Country: Sri Lanka
Primary cause: Victim inattention (?)	Secondary cause: Other (?)
Class: Handling accident	Date of main report: 08/08/2004
ID original source: [Name removed]	Name of source: [Name removed]
Organisation: [Name removed]	
Mine/device: P2Mk2 P4Mk1 AP blast	Ground condition: dry/dusty hard
Date record created: 28/07/2006	Date last modified: 31/07/2006
No of victims: 1	No of documents: 1

Accident report

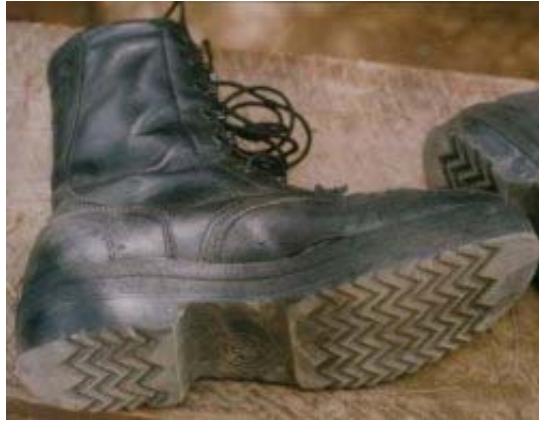
[This is a picture of the kind of boot worn.]

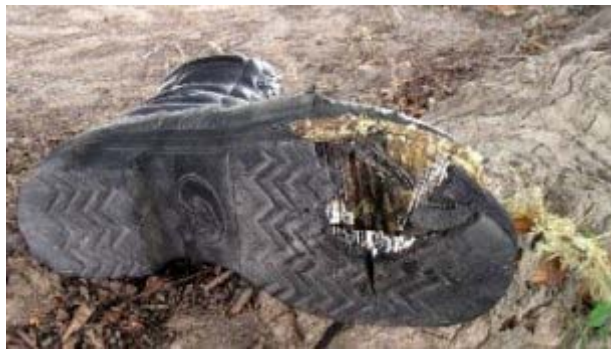
7) Damage to demining equipment: the mine boot worn on right foot by [the victim] was damaged. No other equipment was damaged.

15) BFR mine boot has proved to be very effective in reduction of injuries. From the photographs it can be seen that though extensive damage was caused to outer sole, the inner sole remained intact, thereby reducing intensity of shock wave generated.

- i) All Personal Protection Equipment as per SOP was worn by [the victim] and all other deminers properly at the time of the incident.
- j) Use of mine boots has apparently contributed to reduction of injury to a great extent and limited it to only fractures and avoided possible amputation. The photograph of the damaged mine boot worn by [the victim] is attached.

[This is the picture of the BFR boot worn during the incident – as attached to the report.]

The mine contains 30g Teteryl as its main charge. It was on the surface of ground described as "hard" and "dry". It is possible that the blast vented from the sides and so the exposed position of the mine may have contributed to the unexpectedly reduced injury. None the less, it is possible that the presence of the boot helped to limit injury.
