# DDAS Accident Report

### INVESTIGATION REPORT

INTO MINE ACCIDENT WHICH OCCURRED ON 01 AUGUST 2002 AT M4176 MINEFIELD, BANTEAY MEANCHAY.

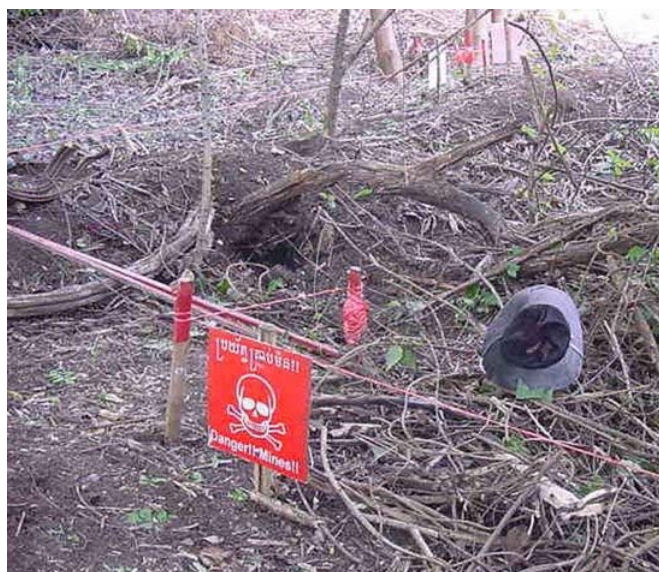
The picture shows the accident site with the Victim's sunhat beside the crater.

A) During conducting Vegetation Removal Drills at minefield M4176, to pull a branch of deadwood which its end buried in a mound of excavated soil from the uncleared area at the head of lane and it was activated and detonated to a buried mine underneath.

A) Yes. A bulldozer was used to clear a field exploding mines as it progressed as well as making a range of mounds at the end of the field which buried deadwood and an unknown quantity of mines. [Demining group] deminers wherever possible, level by level, cleared and continue to clear as many of these mounds as possible. There were mounds of earth at the accident site.

[The ground shown in the photographs is soft and friable with buried, rotting wood – buried by the bulldozer.]

A) All deminers, Section Commanders are to be refresher training on demining drills, basically on vegetation removal drill, Mine detector drill and Prodder and Excavation drill.

6. The investigation team after consideration of all factors makes the following recommendations:
  - a. Strictly reinforce control and monitor by section commander and platoon commander on demining operations performance drills and coaching basic instruction specifically upon its nature.
  - b. All deminers and Section Commanders are to be refreshed training on demining operations drill.
  - c. Mobile Platoon Commanders shall be trained on 1st line and middle management.
  - d. Information from this and other accident/incident investigations should be forwarded to the appropriate CMAC departments for perusal and discussion.

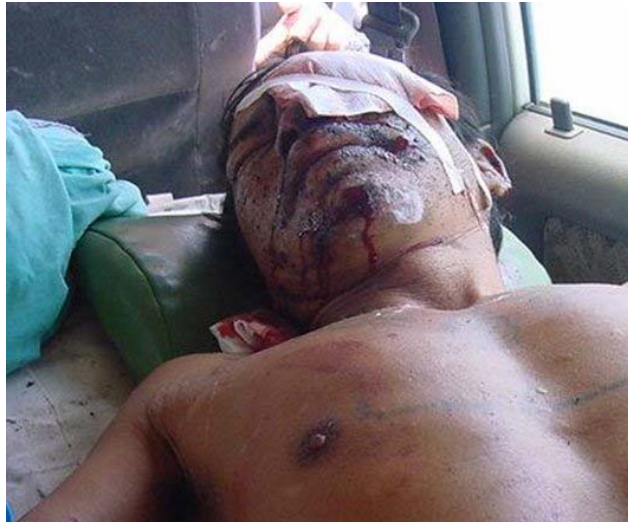
A) Only one person, the victim, was injured. He suffered a blast injury to the face and gravely hurt to left eye, which might be lost sight or blind.

A photograph showed head, left eye and facial injury.
